# Catastrophic Failures and the Net Effect of Design and Construction Errors on Moisture Management, Resilience and the Built Environment

Building Forensics Group

# Gulf Residence Custom Home

# Limited Service Hotel

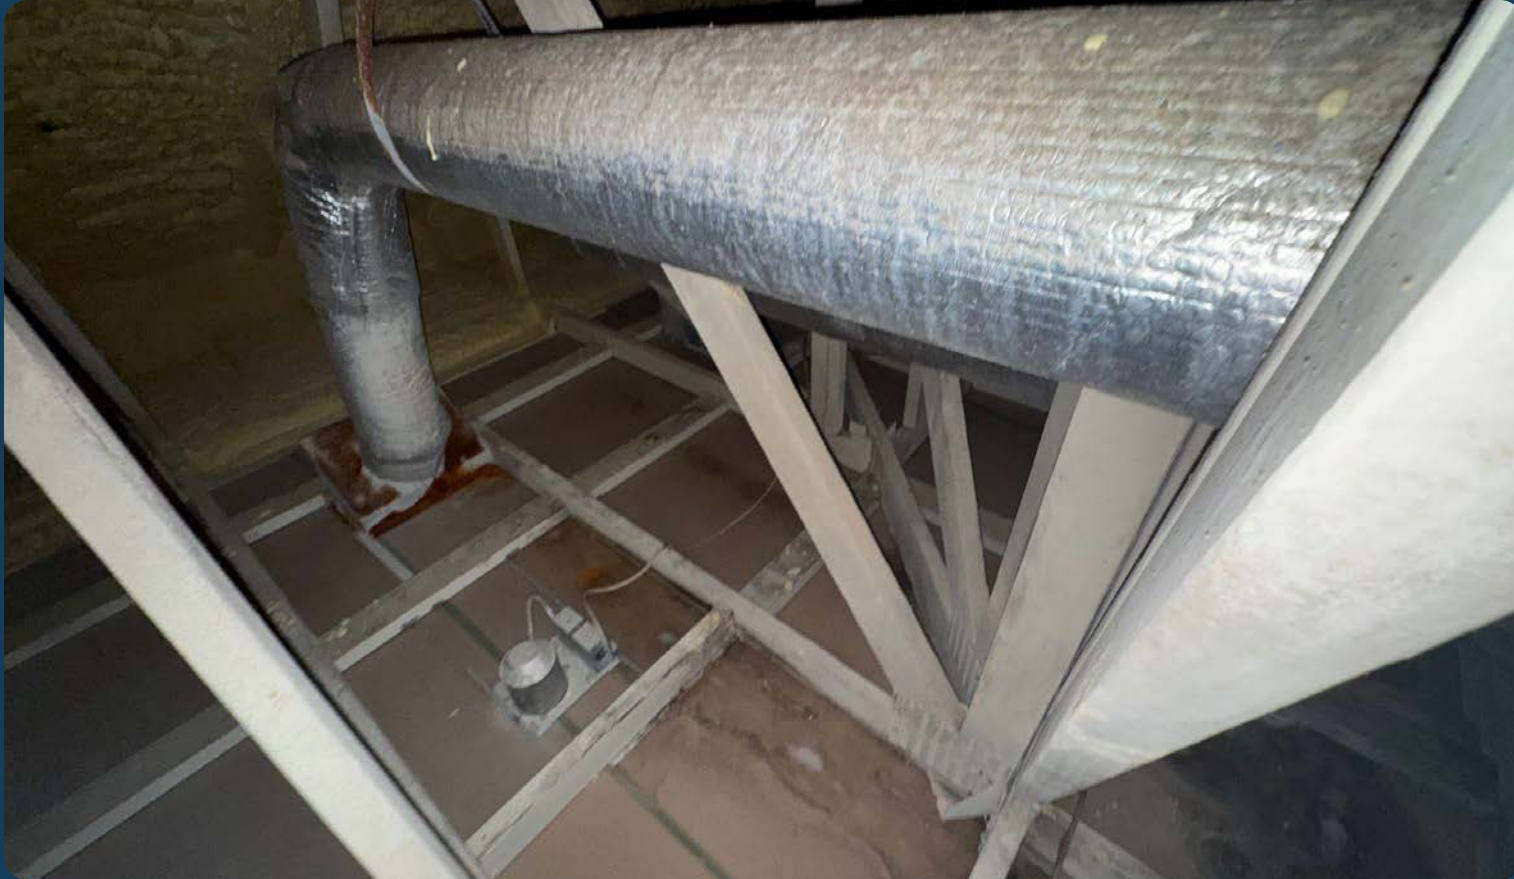
- Support straps not enclosed/wrapped separately
- Transverse joints misaligned with hangers
- Unsealed seams and fittings throughout
- Supply air boot condensation damage
- Moisture and mold damage to duct insulation and attic floor.

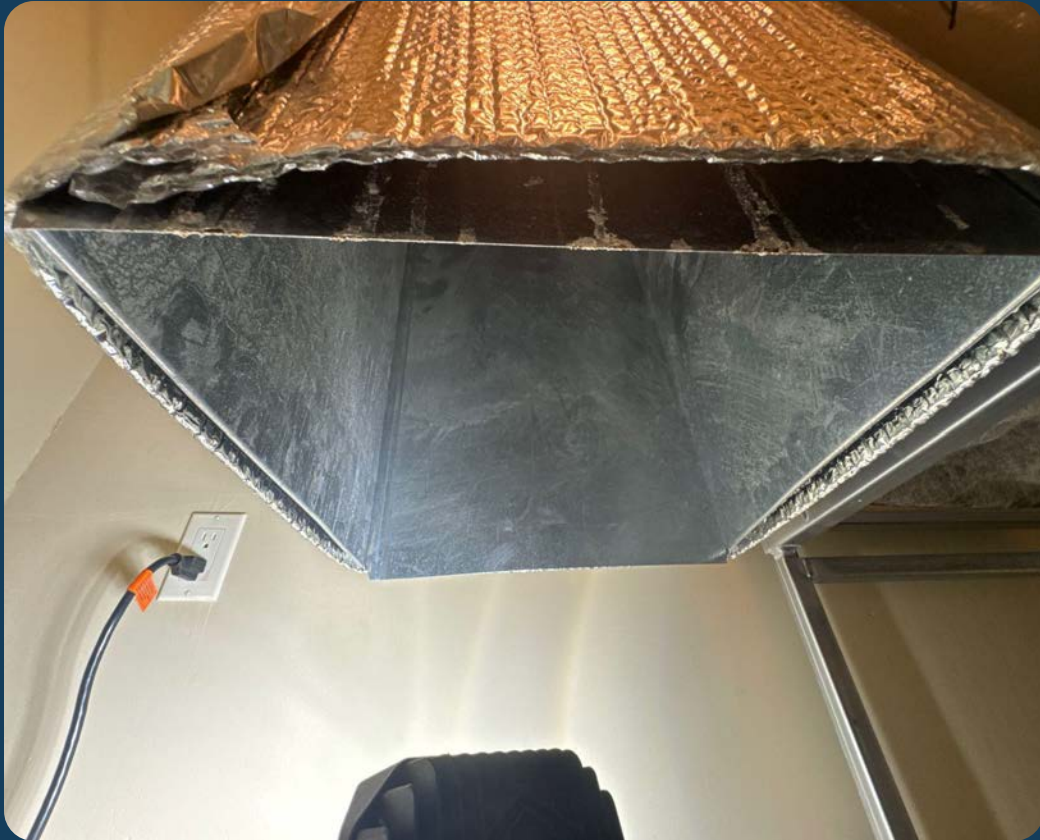
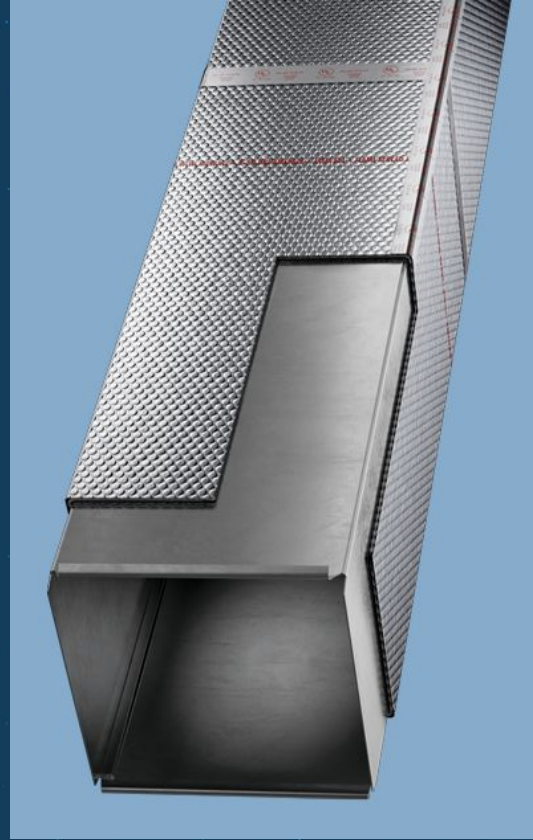
- Condensation drip pattern (left)
- Incorrect insulation termination (left)
- Correct installation (right)

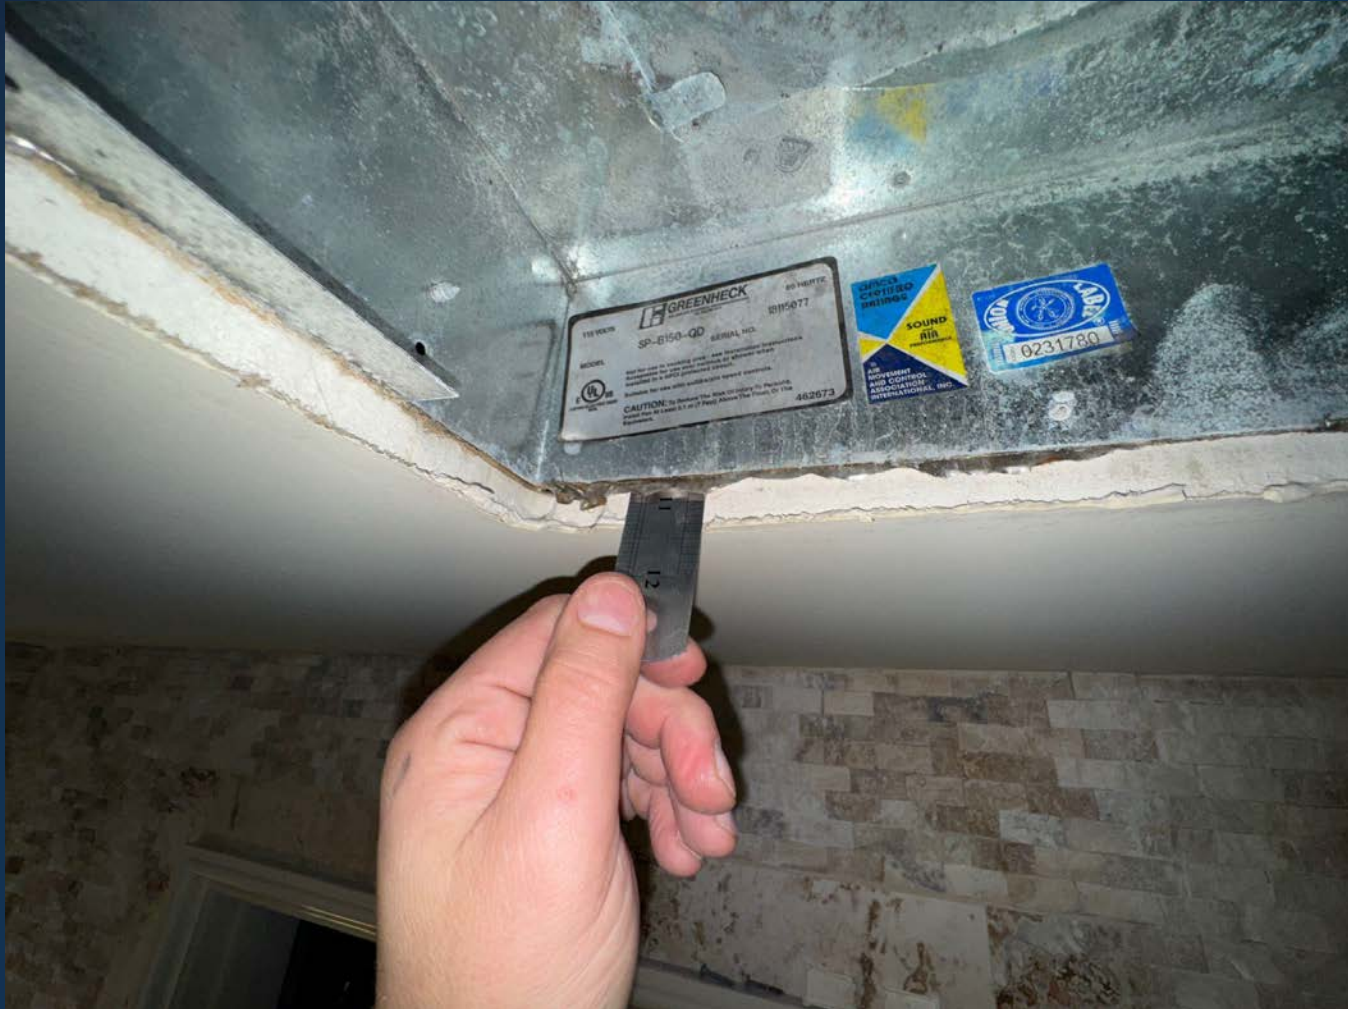
- Steel ruler test showing gap clearance to buffered unconditioned space.
- Exhaust fan not set correctly on GB ceiling.

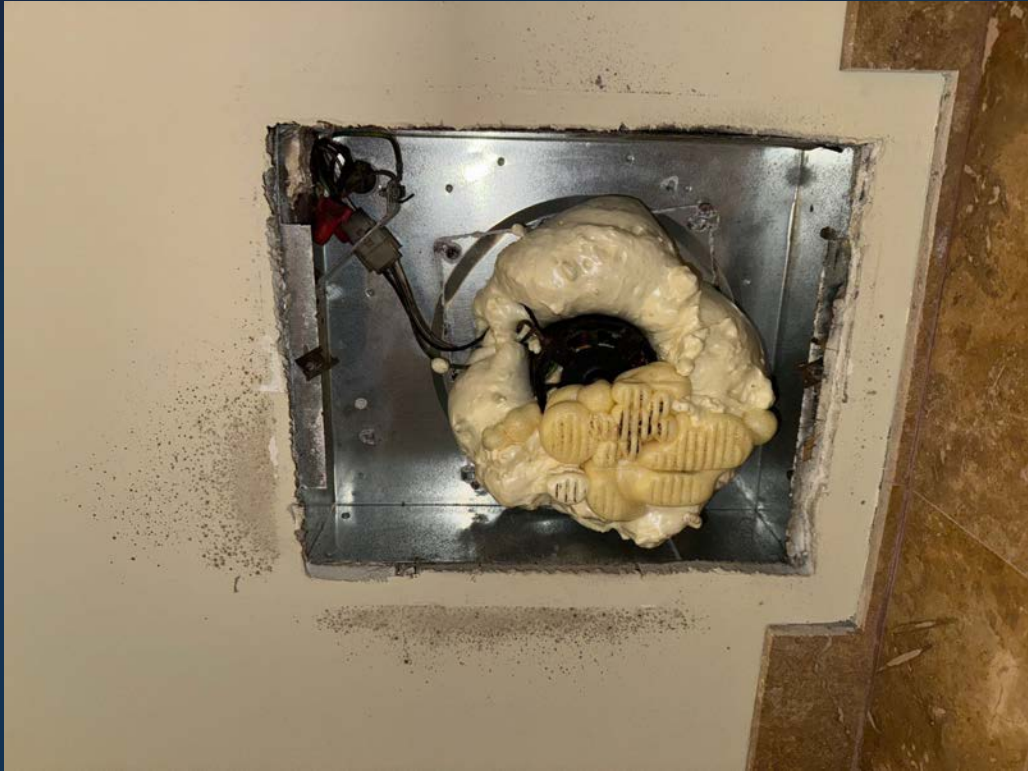
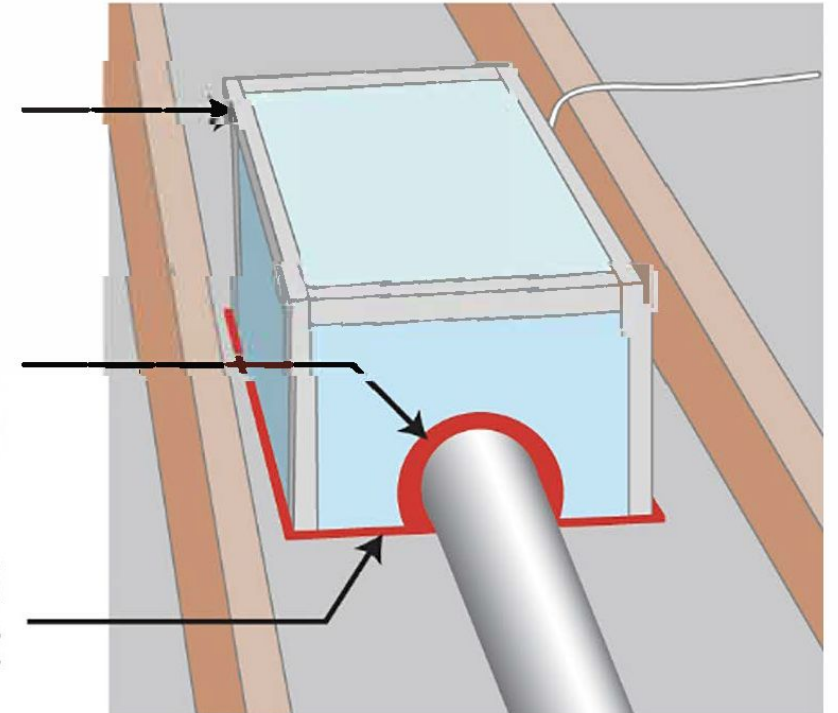
- Suspect mold growth at ceiling adjacent to fan housing
- Insulated exhaust fan housing recommended by Building America Solutions Center and Pacific Northwest National Laboratory (PNNL). Not shown building insulation adjacent to and above housing.

Rigid foam box with  
all seams taped

Rigid foam notched  
around exhaust pipe  
and sealed

Continuous bead  
of sealant

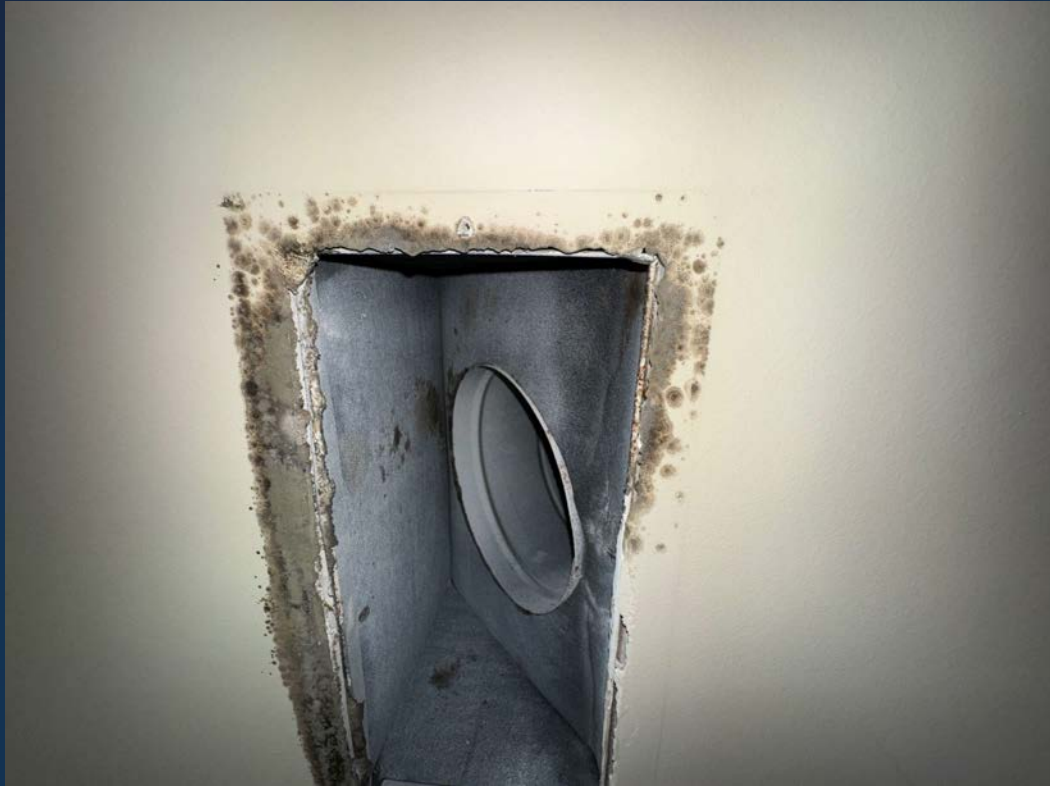
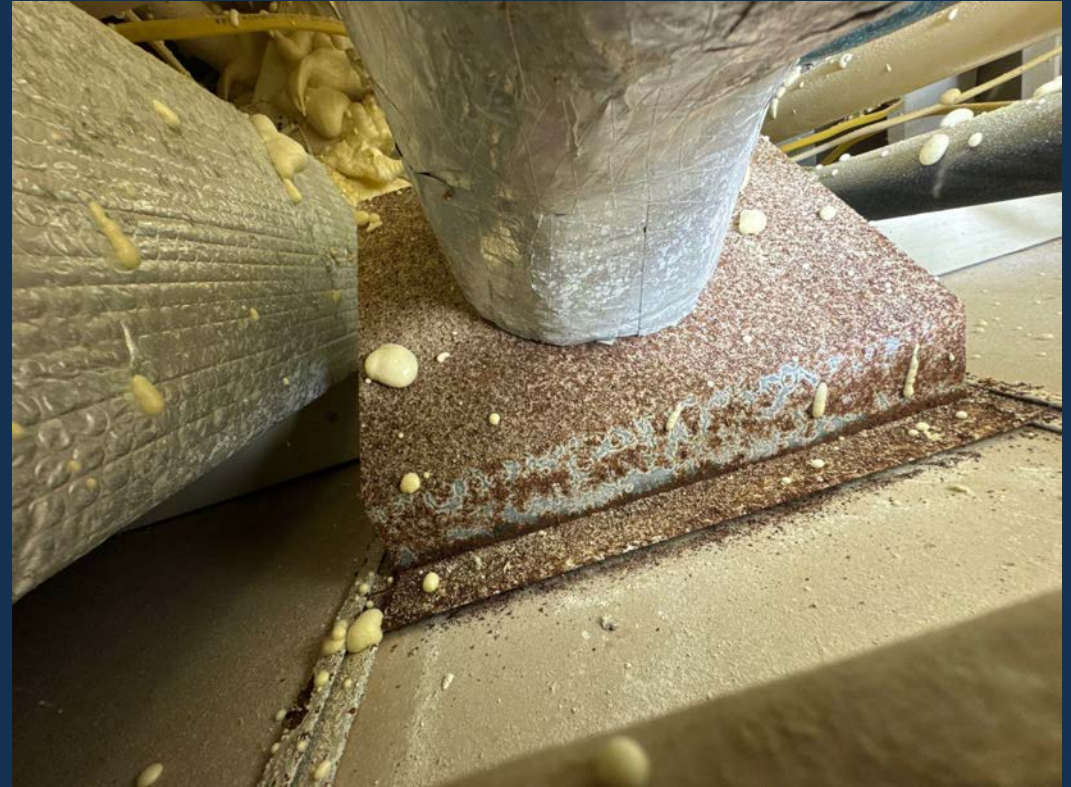
- Suspect mold growth at ceiling adjacent to supply air boot
- Corrosion and possible mold growth on supply air boot.

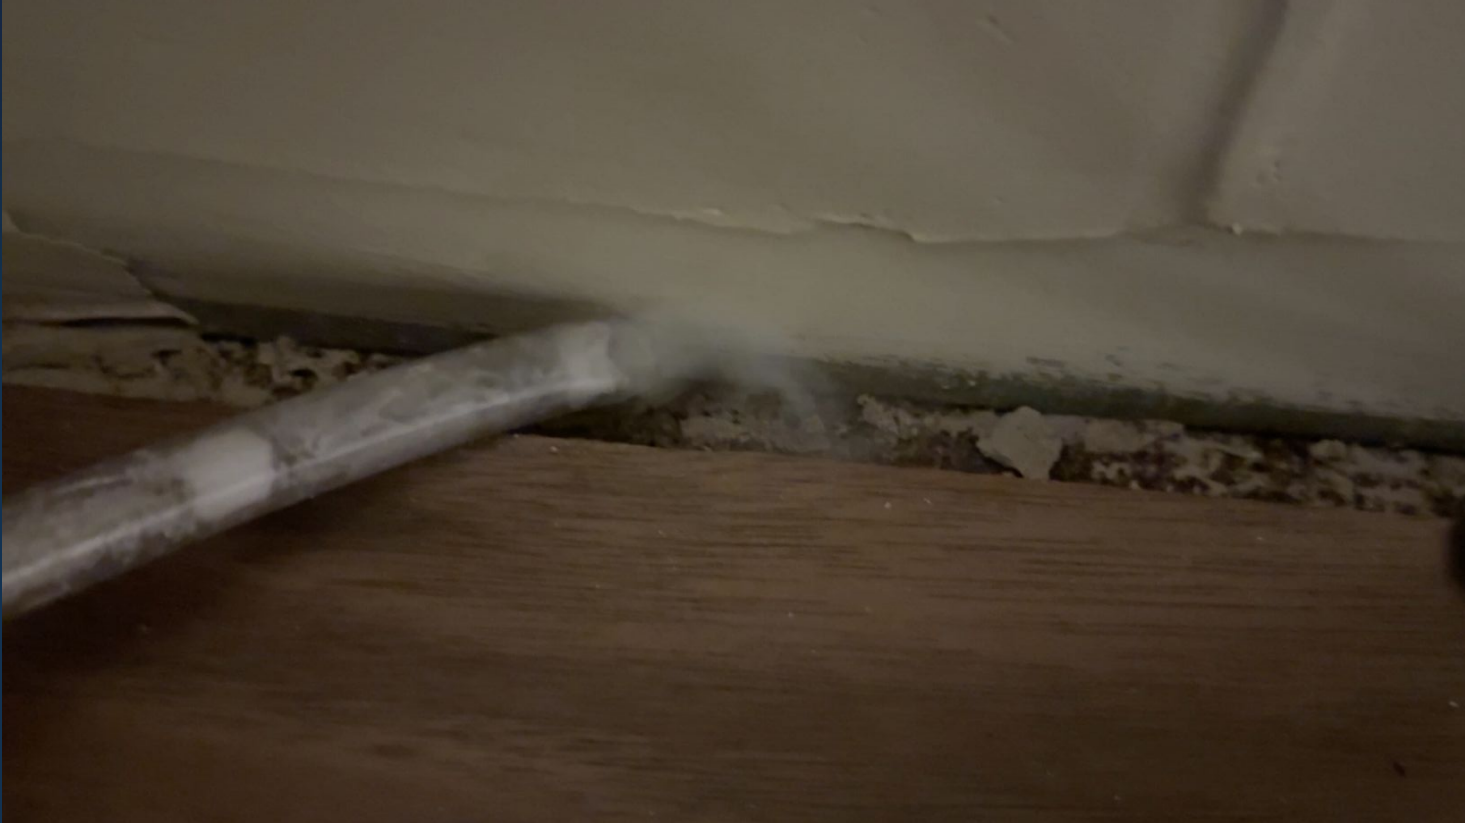
- Gaps and unplanned pathways for return air.

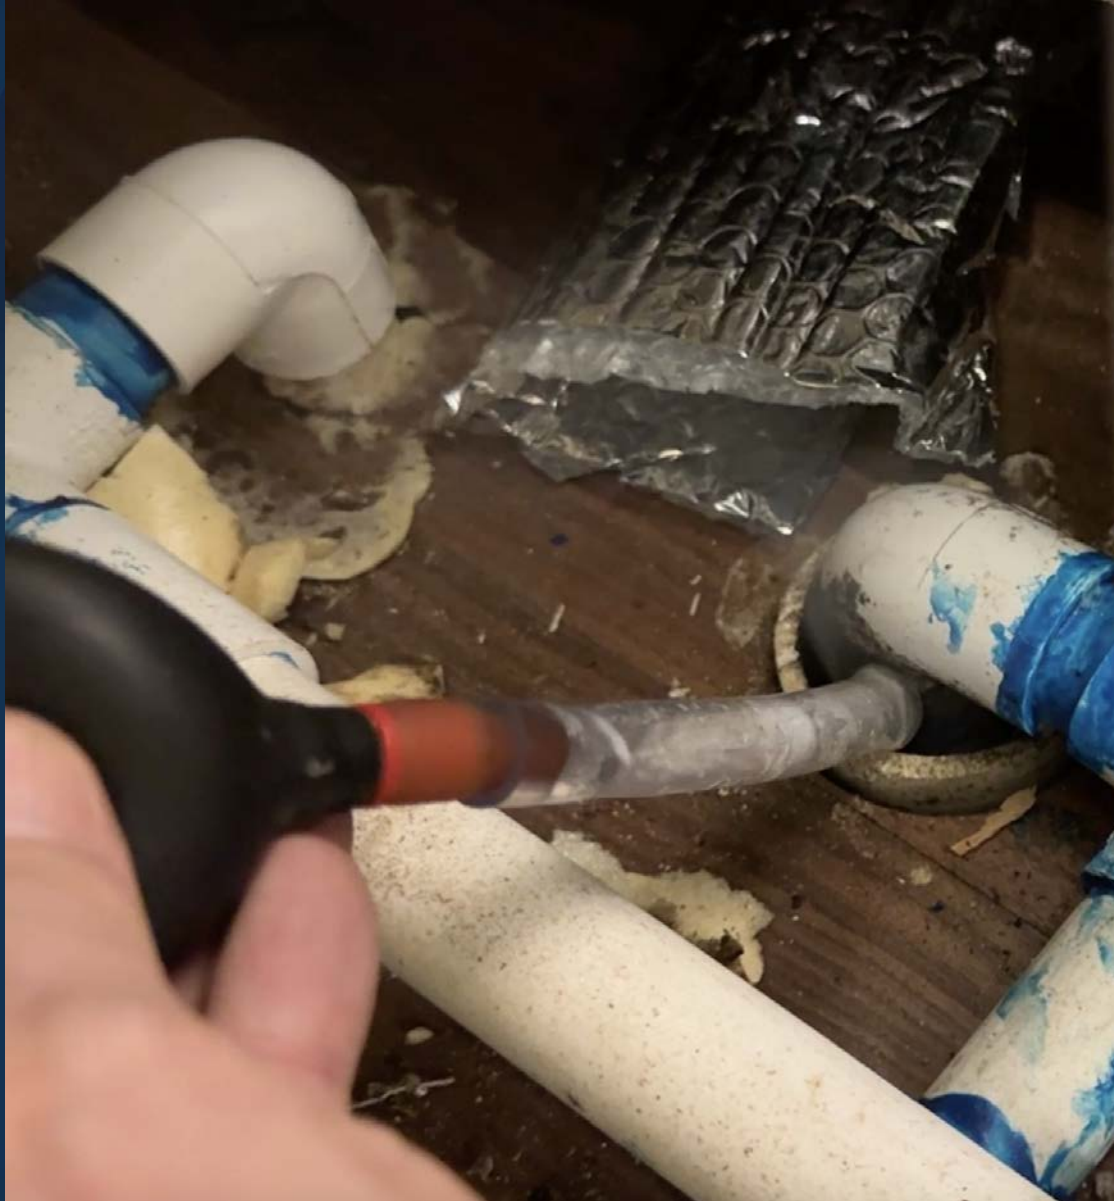
- Smoke visualization testing showing air infiltration up through the condensate drain at the indirect drain location

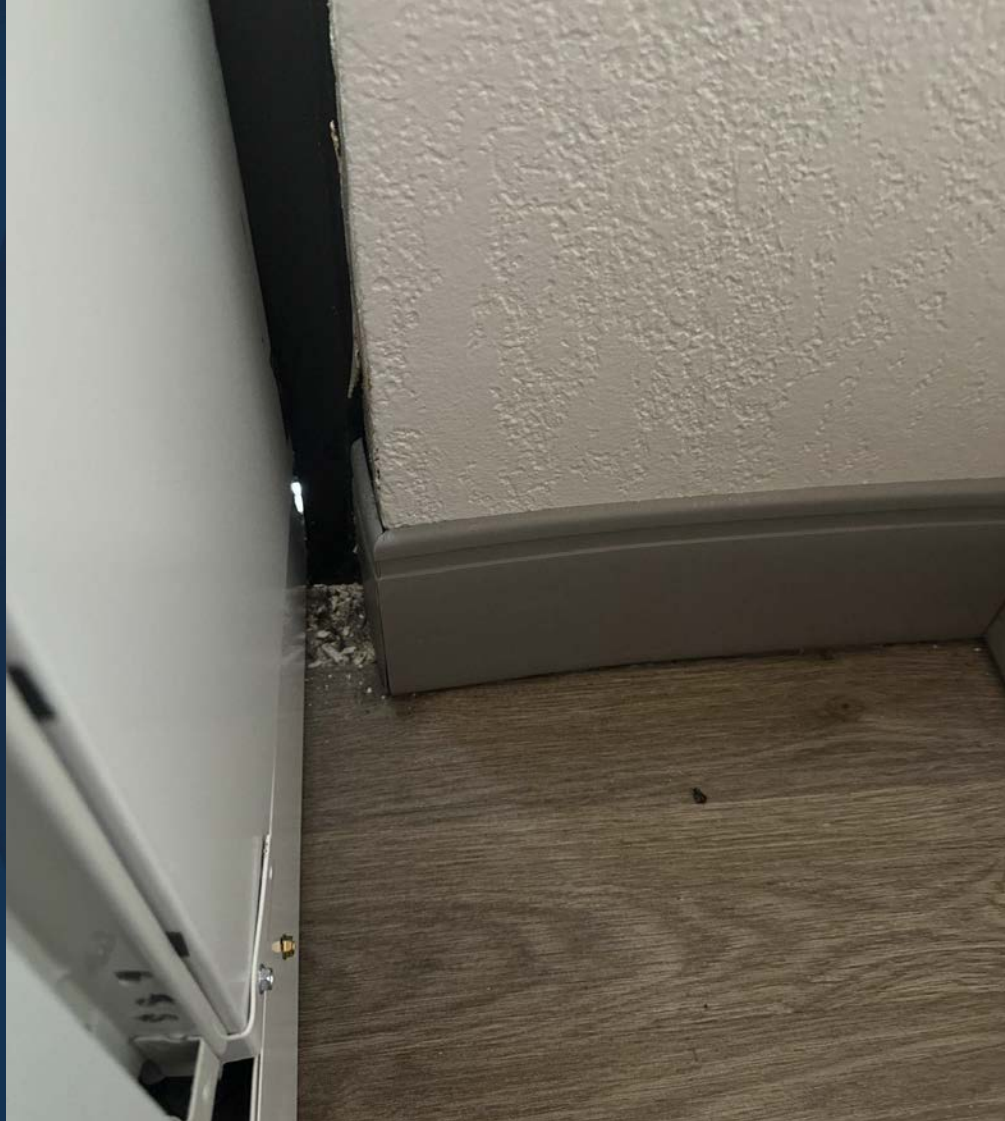
- Unit 111. Note: Opening in PTAC wall louver for air infiltration into the room.

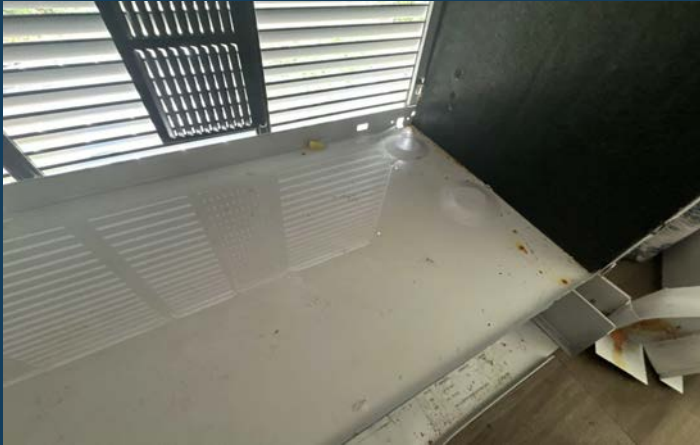
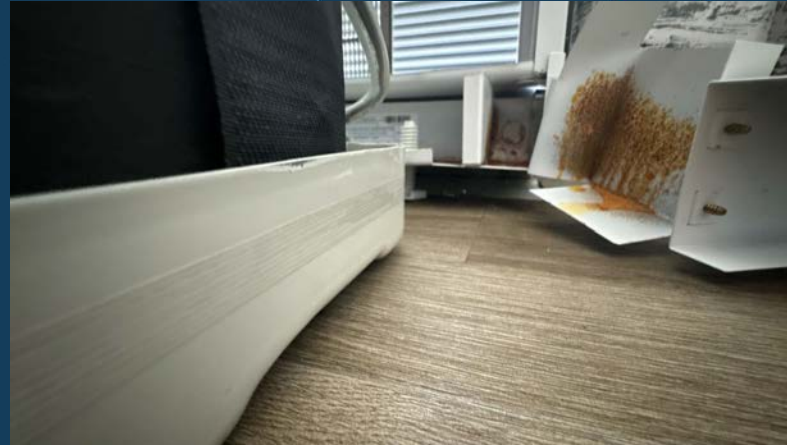
- Standing water and corrosion in PTAC sleeve (right)
- Corrosion staining at PTAC casing end cap (right)

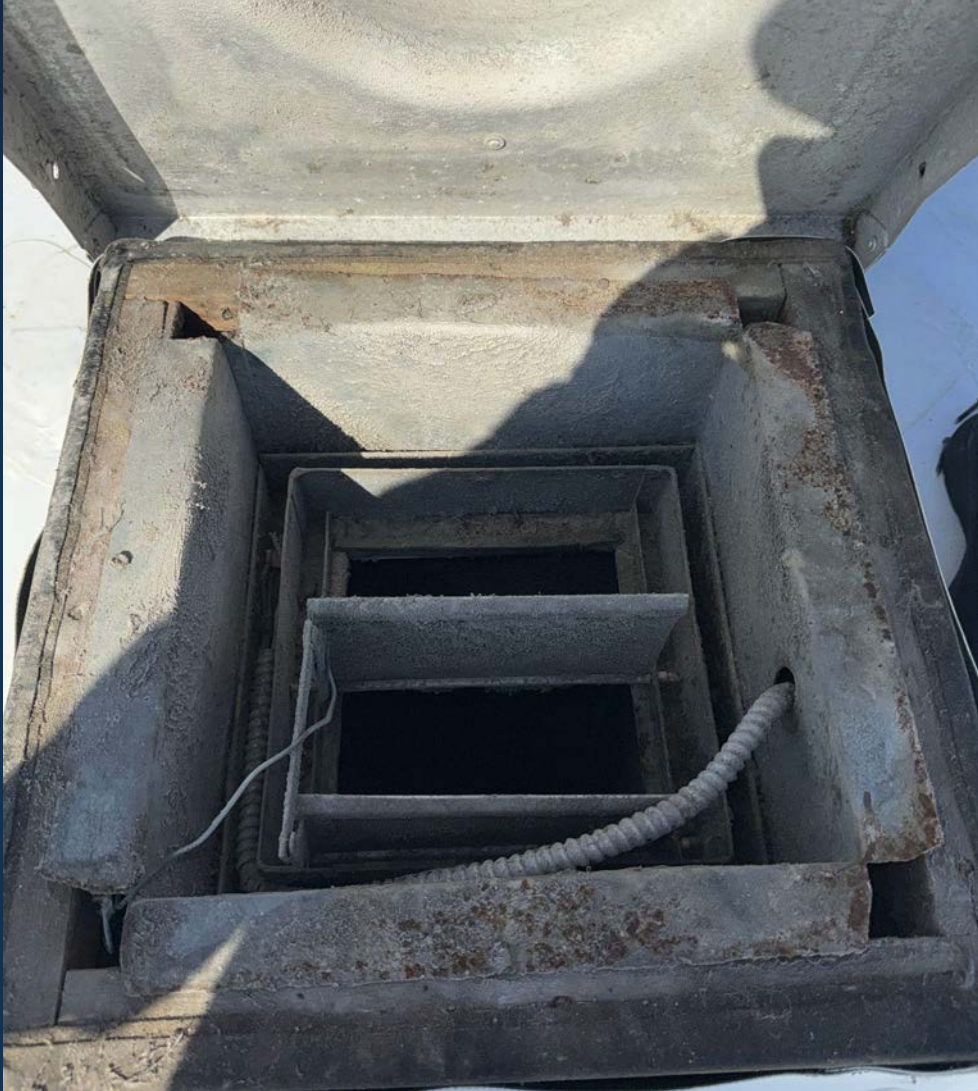
- Exhaust shaft - Openings at duct corners extracting air from wall cavities

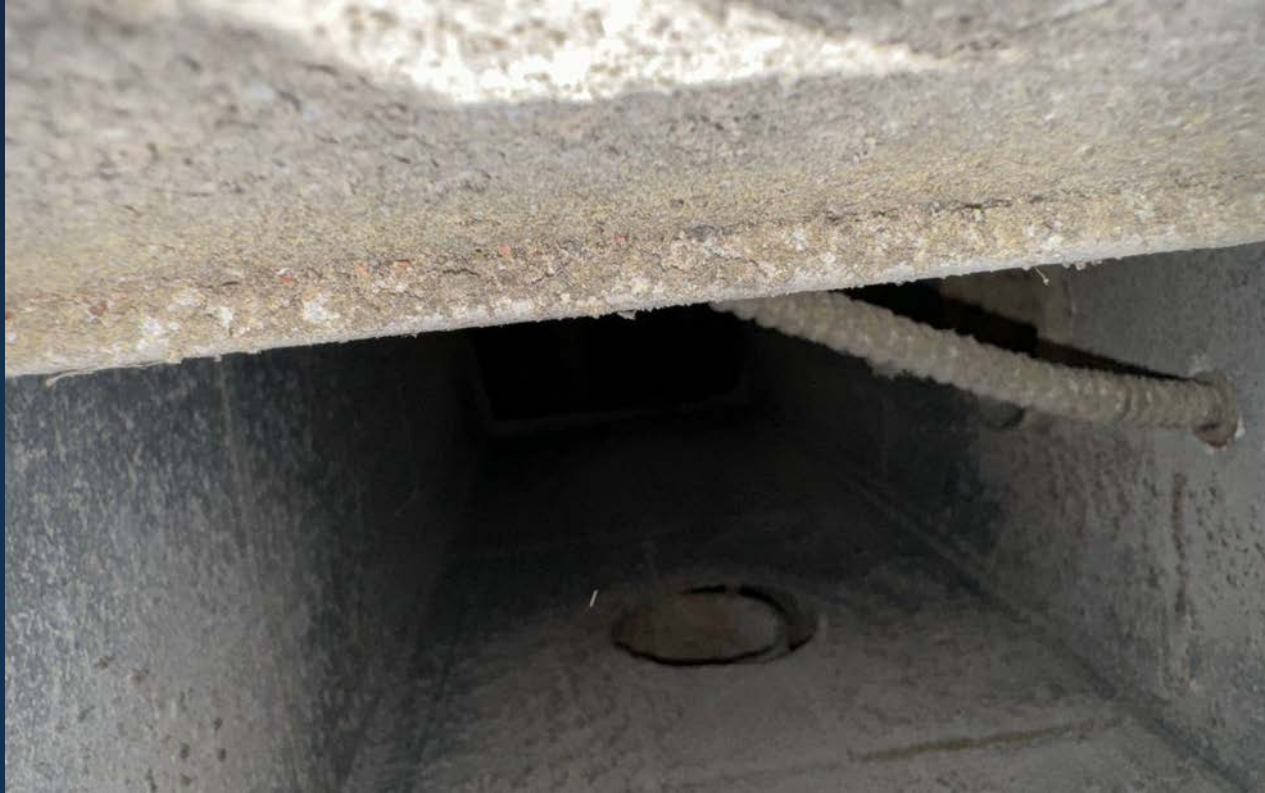
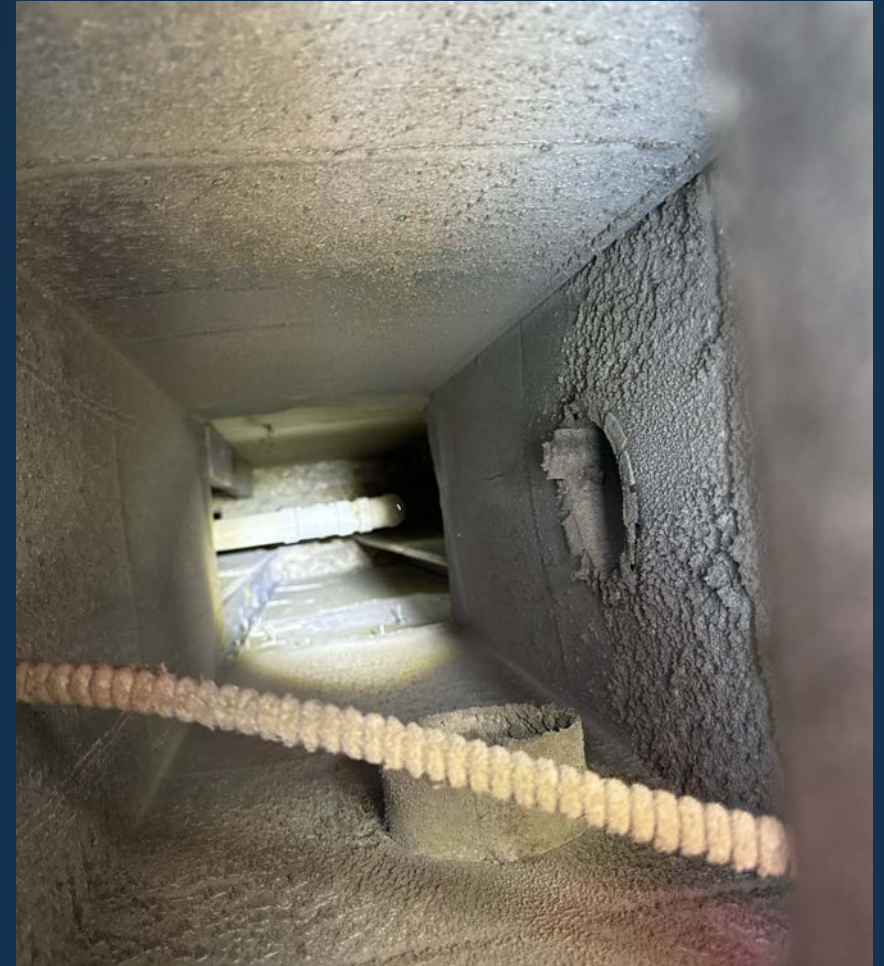
- Air gap at cable penetration; absent sub-duct (left)
- Multiple unsealed shaft penetrations

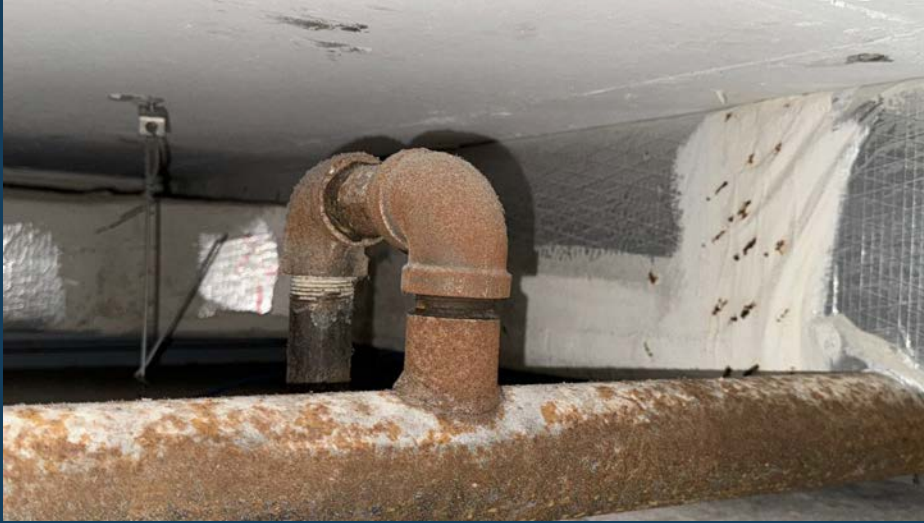
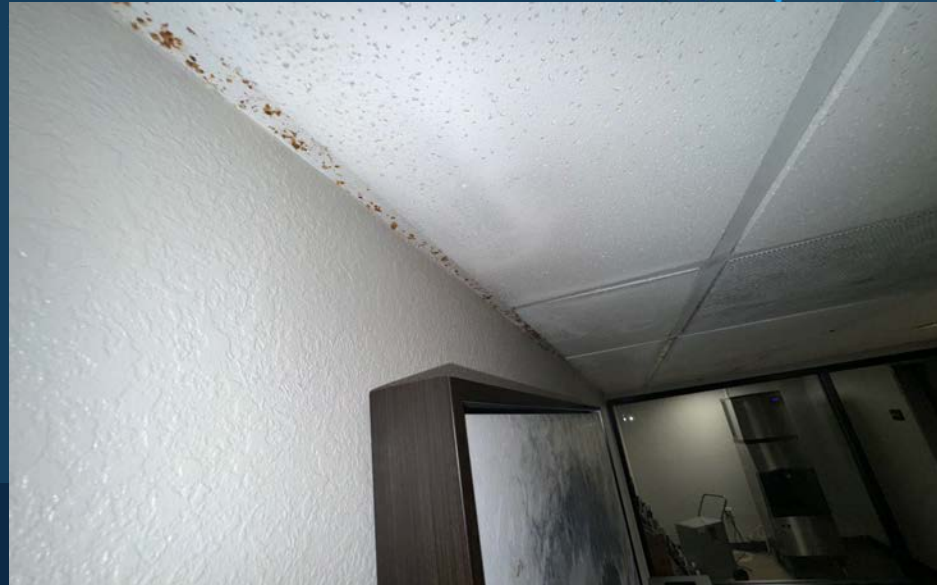
- Corroded fire suppression piping above 5th floor ceiling (top left)
- Corroded Ceiling Grid from Chronic High Humidity (bottom right)

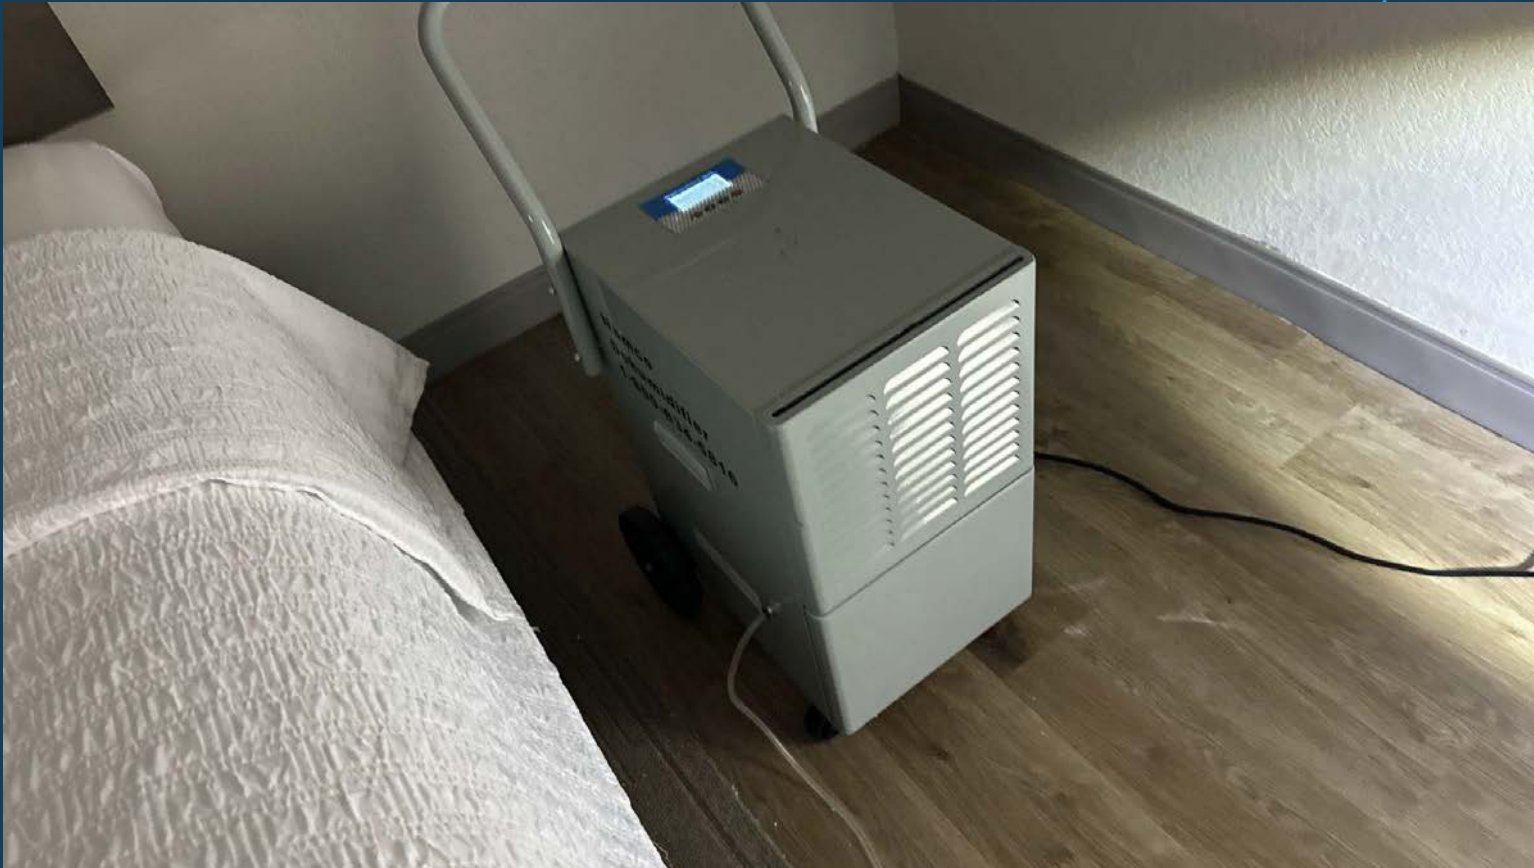
- One of two active dehumidifiers shown in a second floor room to maintain acceptable conditions

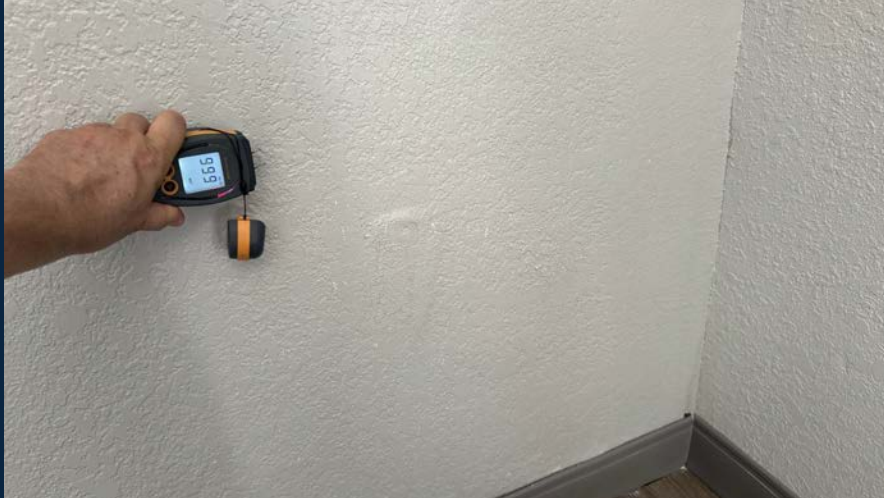
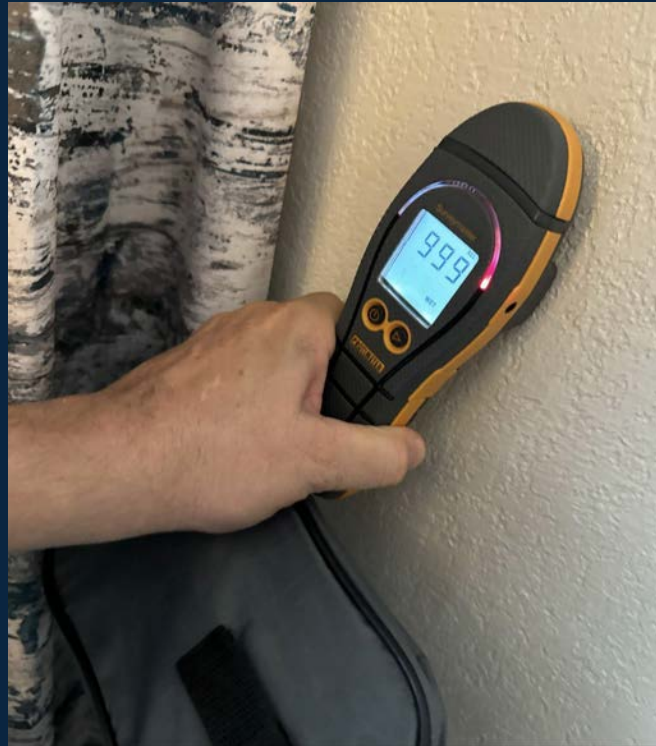
- Room 519 - Moisture measurements of demising wall near PTAC - Wet GWB
- Room 213 - Moisture measurements indicating wet GWB

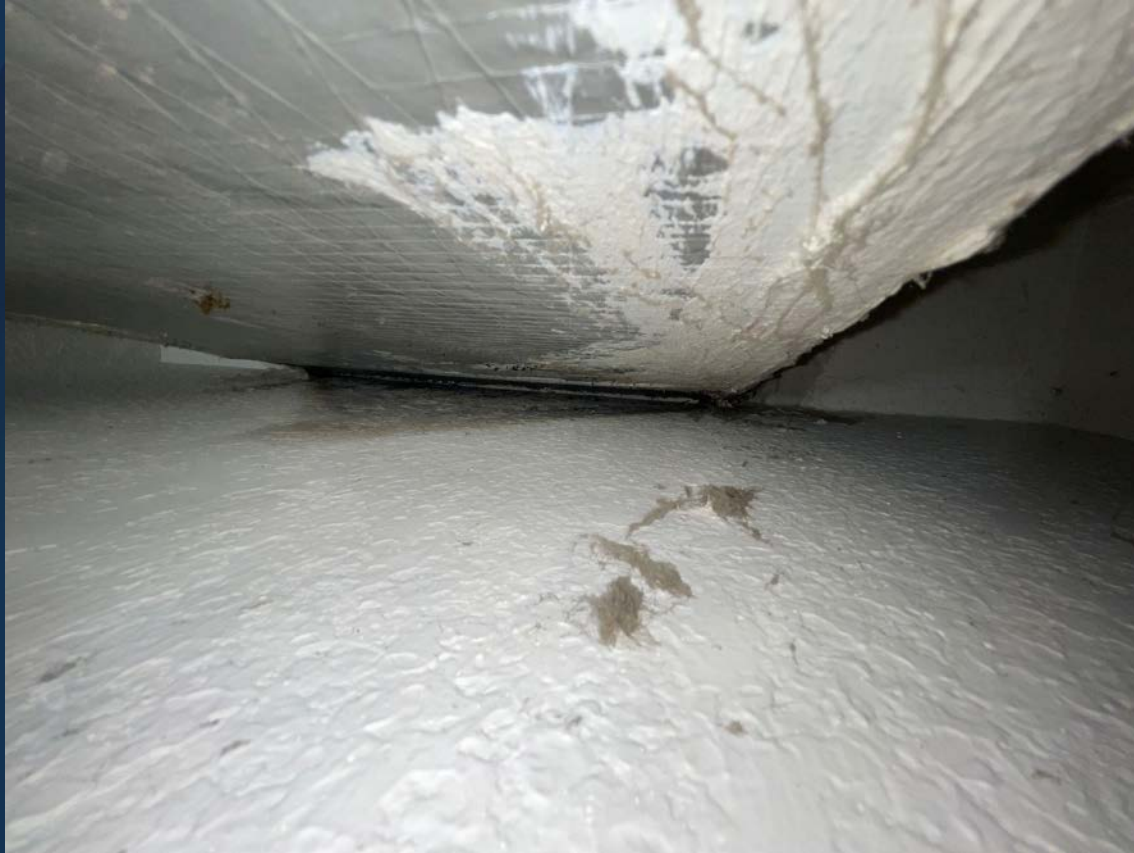
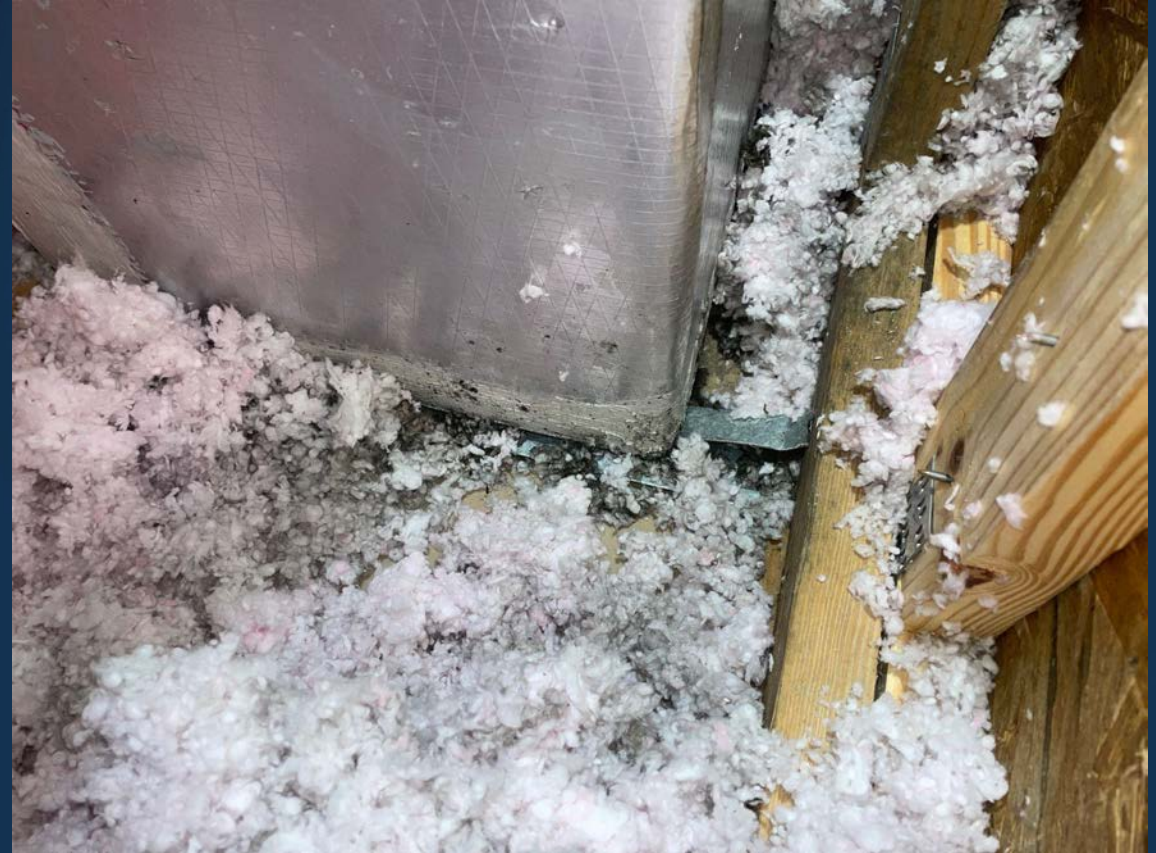
- Backside ceiling gap between supply discharge duct and wall. Unplanned airflow pathway (left)
- Attic side of supply discharge duct/plenum. Note: Condensation, SMG and air leakage site (right)

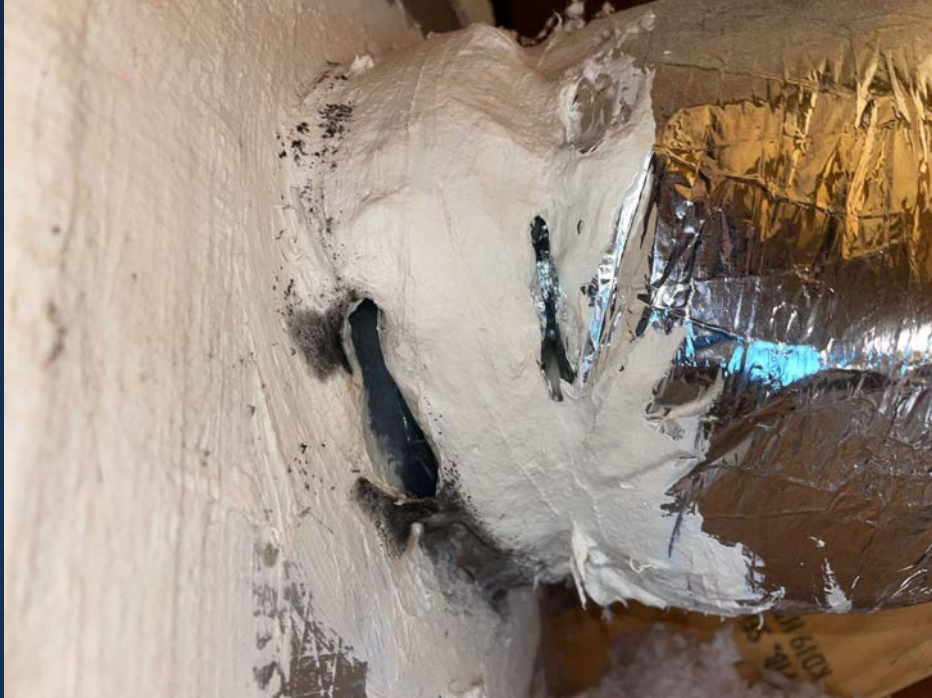
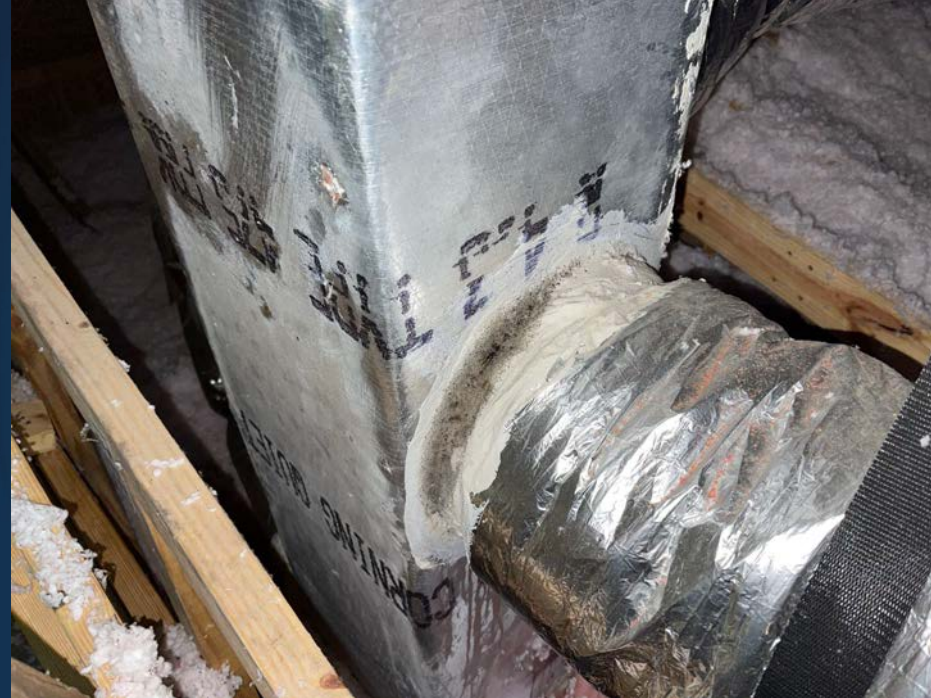
- SMG, ghosting and air leakage (left)
- Condensation and SMG

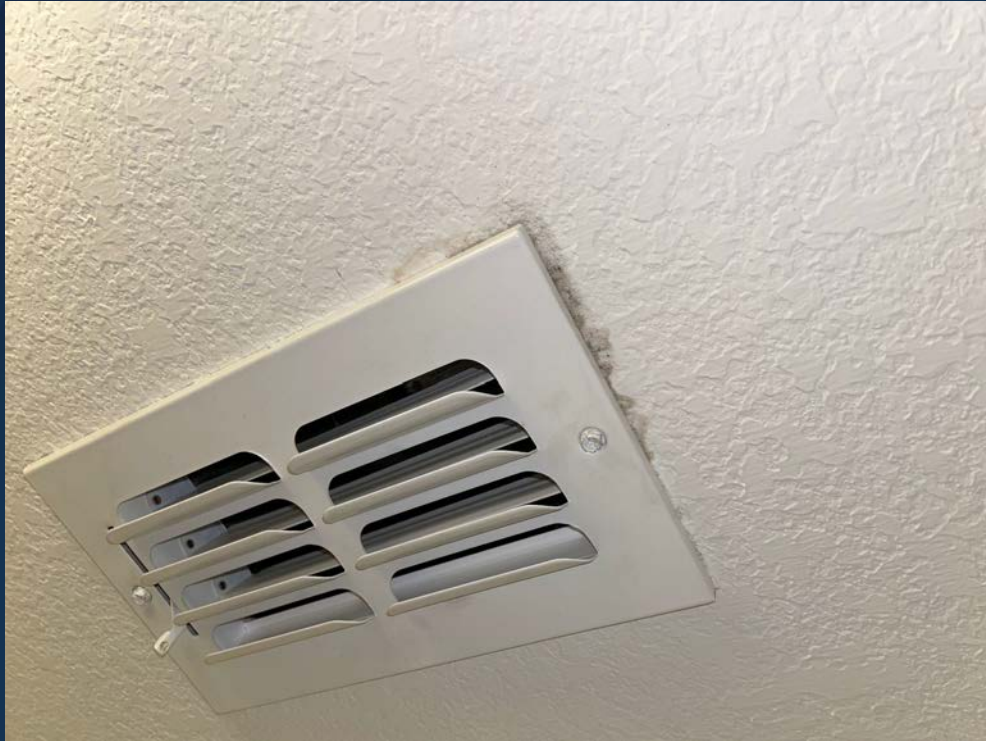
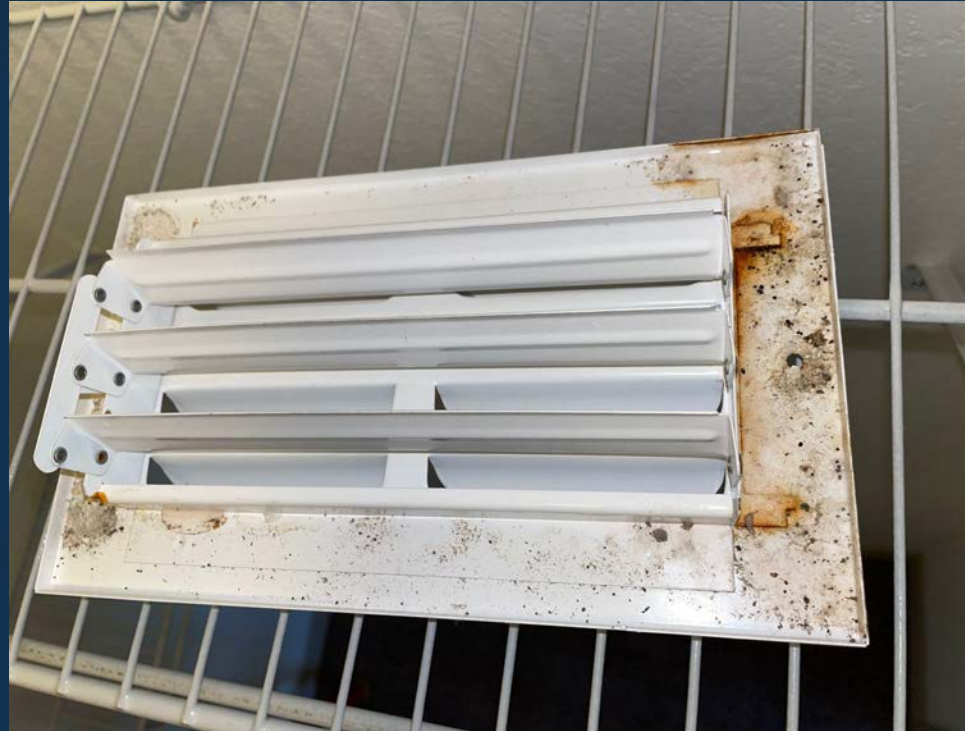
- Air leakage, condensation and SMG (left)
- Evidence of condensation, corrosion and SMG (right)
