# Catastrophic Failures and the Net Effect of Design and Construction Errors on Moisture Management, Resilience and the Built Environment

Building Forensics Group

# Gulf Residence Custom Home

# Limited Service Hotel

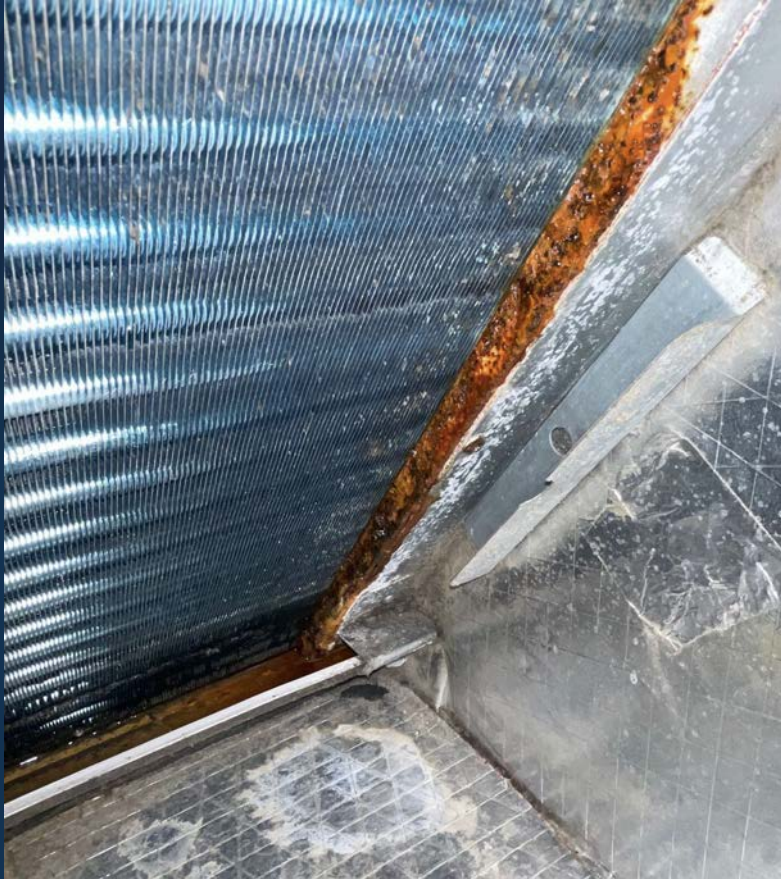
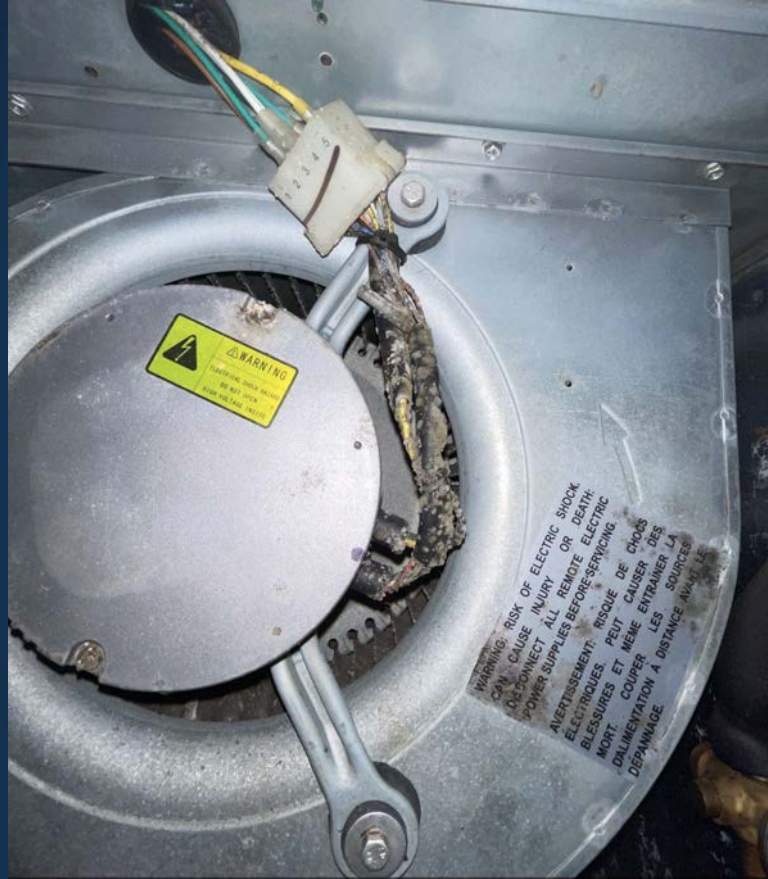
- Corrosion and SMG on cooling coil (left)
- SMG on fan wiring

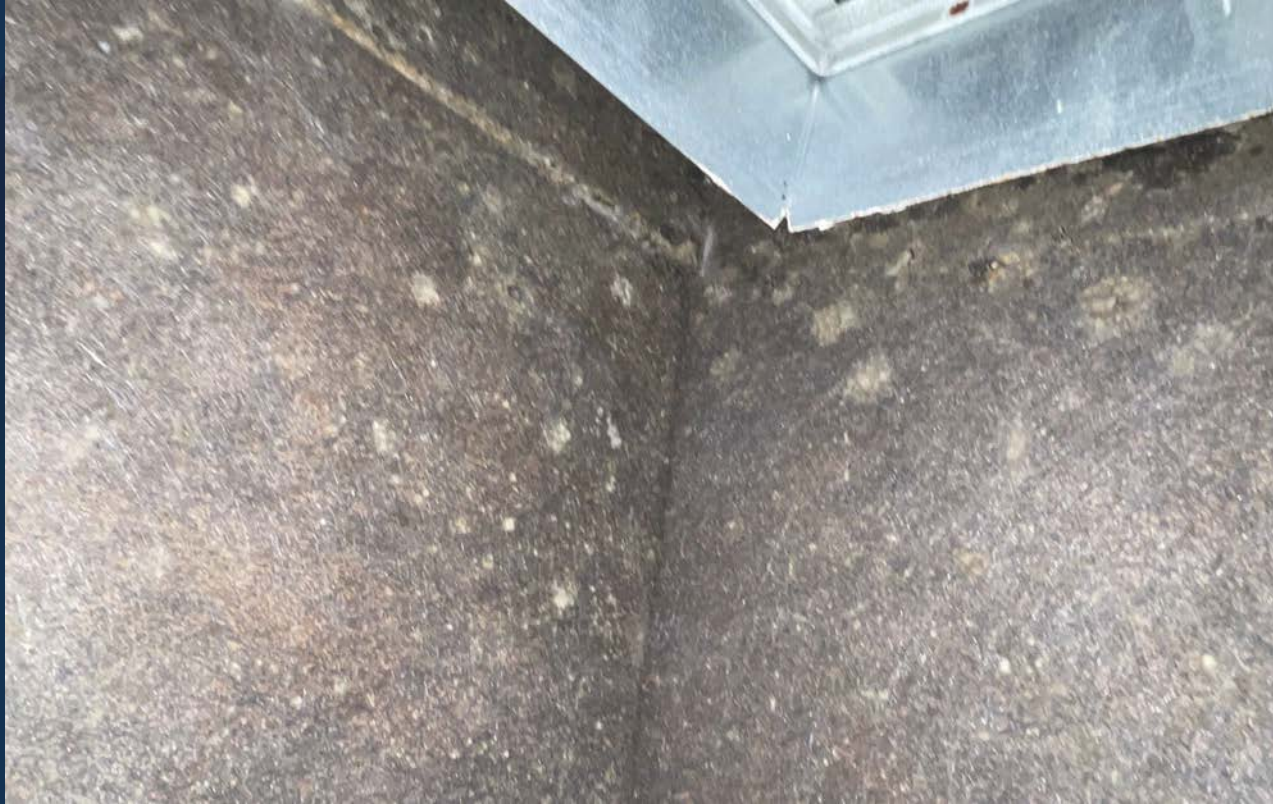
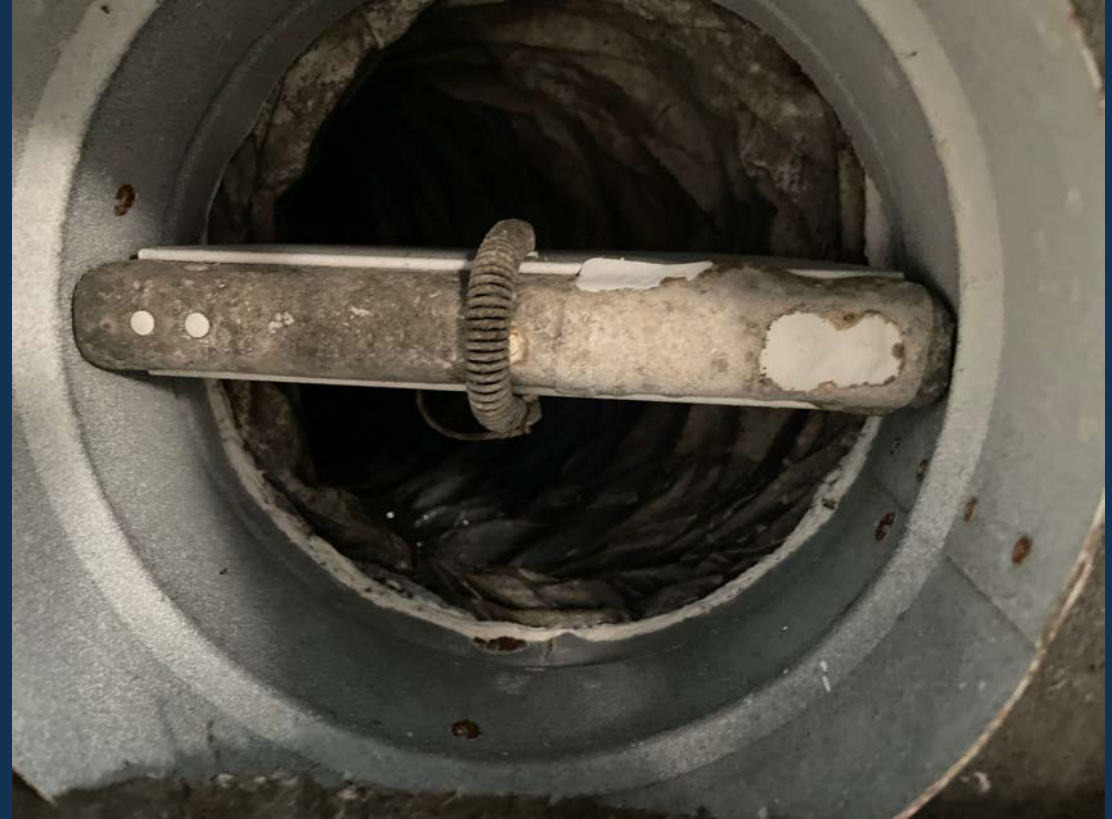
- SMG inside supply discharge duct at radiation damper (left)
- SMG on dirt on radiation shield and flex duct (right)
