# Revisiting the Critical Link Between Engineering Mechanics and Enclosure Performance

"Systems thinking" is a term that is discussed at times in Building Science. But what if systems thinking asks us to consider more factors in the long term viability of enclosure integrity? While the relationship between structural movement and a structure's usefulness to its intended purpose has been well developed throughout the history of design and construction, that understanding has not always translated well into satisfactory enclosure performance.

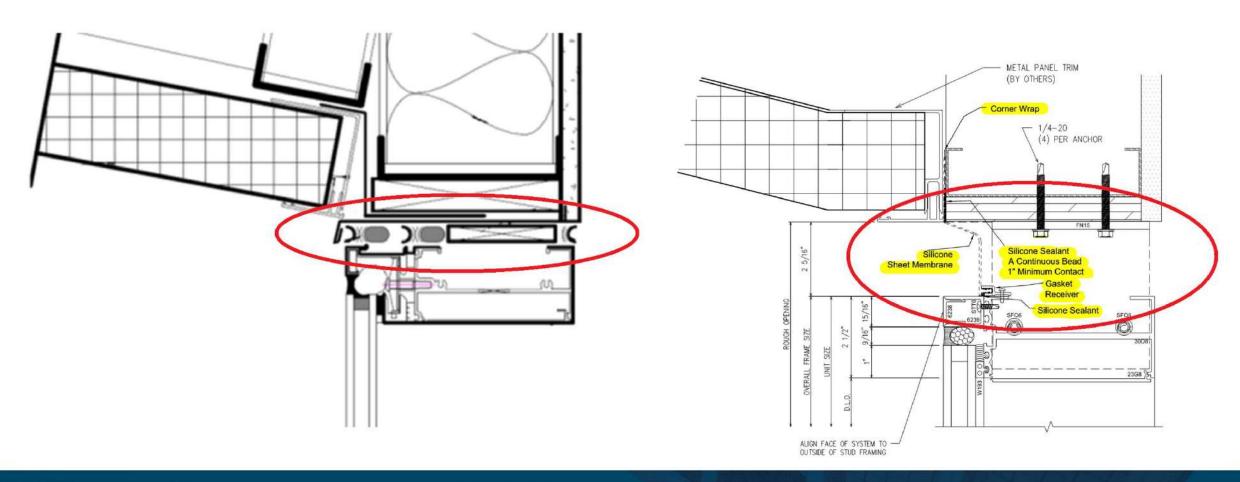
Case Study 1: Compounded Deflections and Curtain Wall

• RFI Question #2: Are you sure?

• RFI Response #2: Use 2-5/16" (L/360 at the largest span was 1")

- Case Study 1: Compounded Deflections and Curtain Wall
  - 6-week delay (RFI process and coordination)
  - Change order
- Optimal Scenario: movement is defined in contract documents before bidding
- Last Call Scenario: movement is coordinated during shop drawing phase
  - The sooner everyone knows what needs to happen, the more efficiently they can act upon it

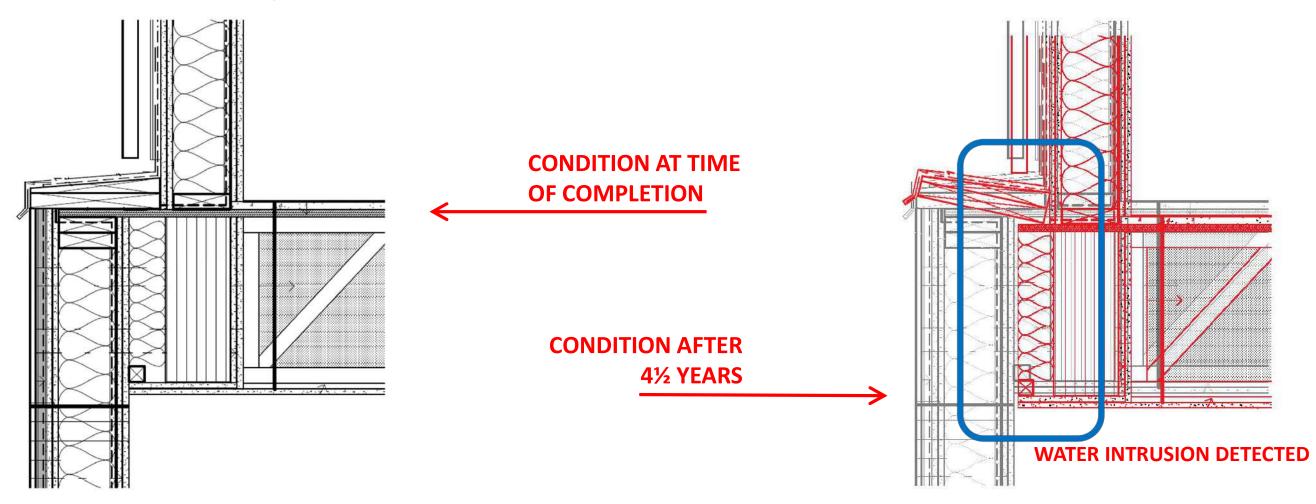
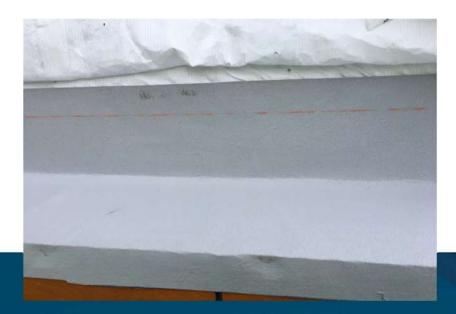
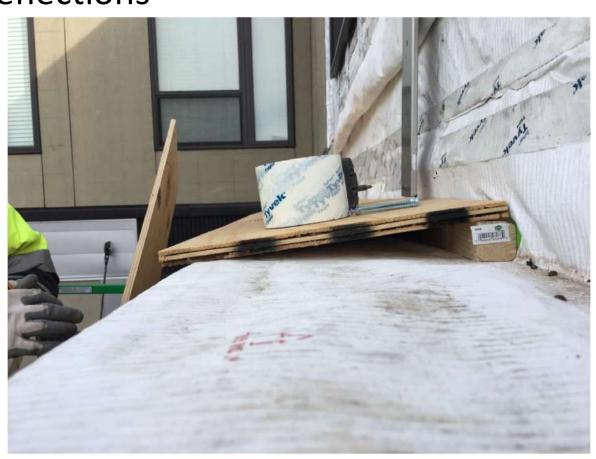
- Case Study 2: Wood Framed Stealth Deflections
- Sometime the movement potential is not as obvious

- Repairs made at all setback locations
  - New pitch of 2:12
  - High temp self adhered membrane flashing approved for use on low slope surfaces

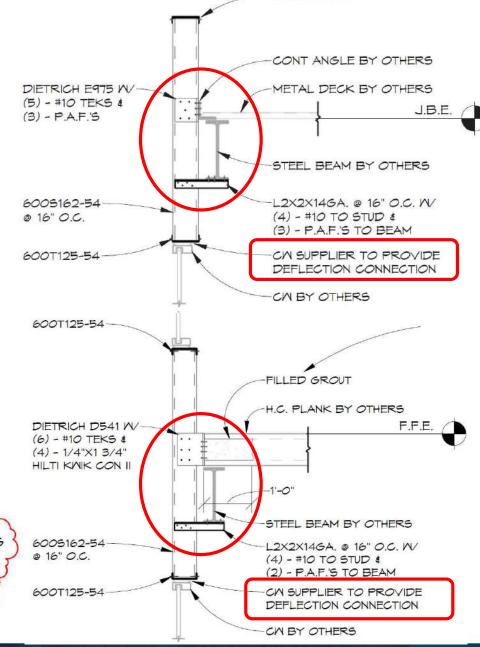
- Case Study 3: Stacked Ribbon Window/Steel
  - But steel stud supplier's shop drawings
    - Requested change to fixed connection between studs and supporting structure
    - Requested that window supplier provide movement accommodation at their head framing condition

A.O.R./E.O.R. NOTE: APEX RECOMMENDS FRAMING AS SHOWN VERIFY LOAD PATH IS ACCEPTABLE. REF. 8, 28/54.5 FOR SIM. STUD LOAD PATH ATTACHMENT TO BEAMS. DETAIL CUT 5/54.4 DOES NOT WORK @ MIDE "RIBBON" MINDOMS.

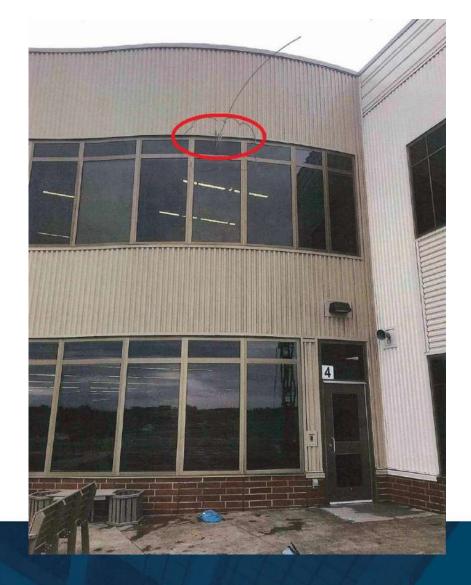
- Case Study 3: Stacked Ribbon Window/Steel Stud Infill
  - Window head conditions would leak early spring after seasonal cycle of winter snow load deflection followed by spring snow melt relaxation

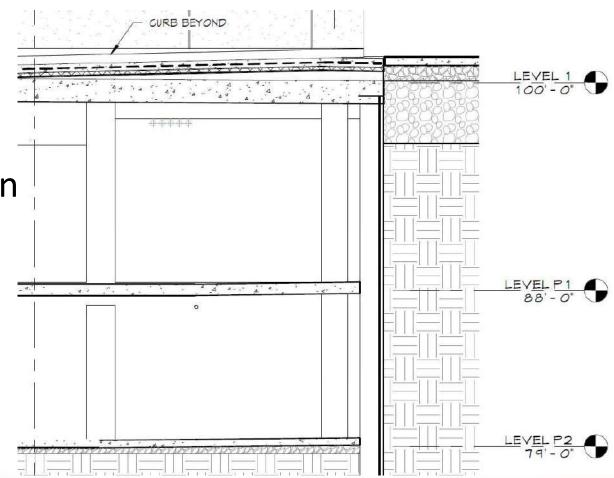
Case Study 4: Parking Deck Surface Slopes/Water Infiltration

Multi-level parking structure below grade

Owner goal of minimizing excavation depths motivated design team to reduce surface slopes

• Range of 1% - 1 1/2%

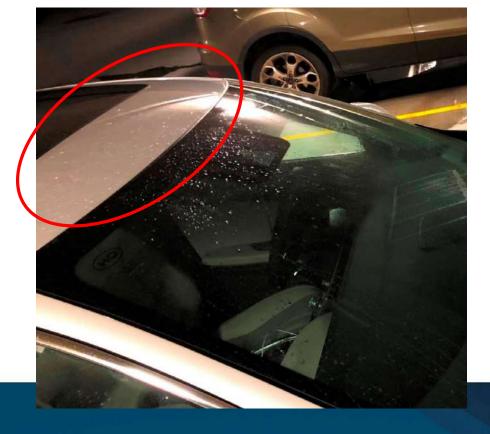
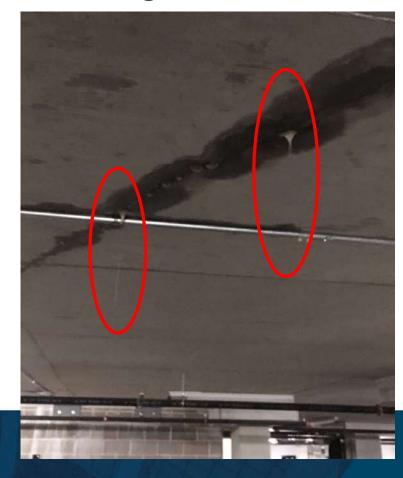
• Case Study 4: Parking Deck Surface Slopes/Water Infiltration

After one seasonal cycle, car finishes on lower level began to show

damage

- Case Study 4: Parking Deck Surface Slopes/Water Infiltration
- Movement of slab changed surface slope from adequate to inadequate
  - Enclosure no longer protected cars below
- Persistent standing water on upper ramp level throughout winter months

- Moisture runoff changed from neutral to alkaline
- Vehicle owners changed from happy to upset
  - Parking structure owner paid for auto finish repair work
  - Vehicular traffic coating added ~ \$355,000

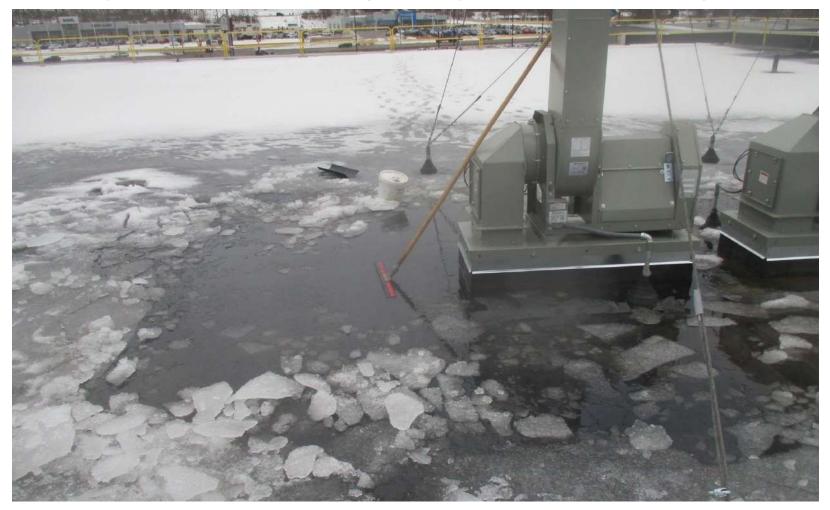
Progressive deflection from ponding instability

- Case Study 5: Roof Ponding/Adaptive Reuse Project
- Design team went back and performed ponding analysis
  - Existing framing confirmed to be stable under sustained loads

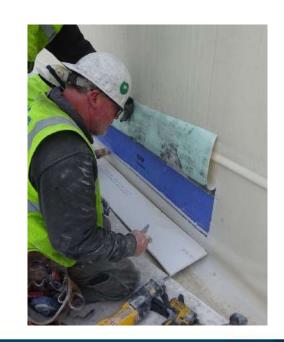
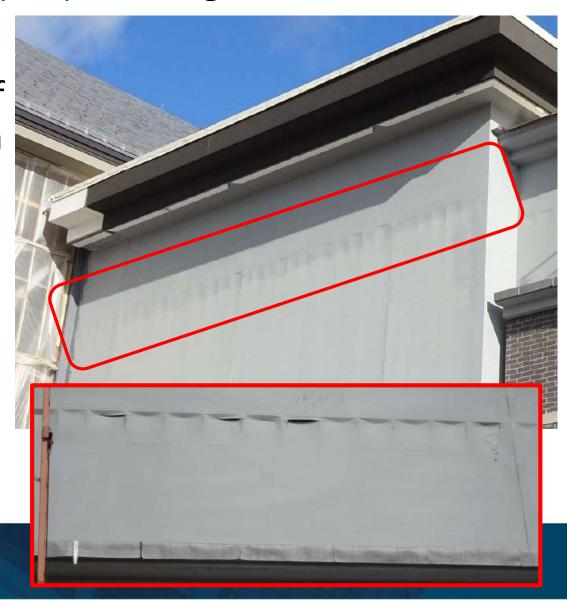
Distress first observed on outside face of exterior sheathing at roof deck elevation

Inspection openings created on rear side of parapet wall

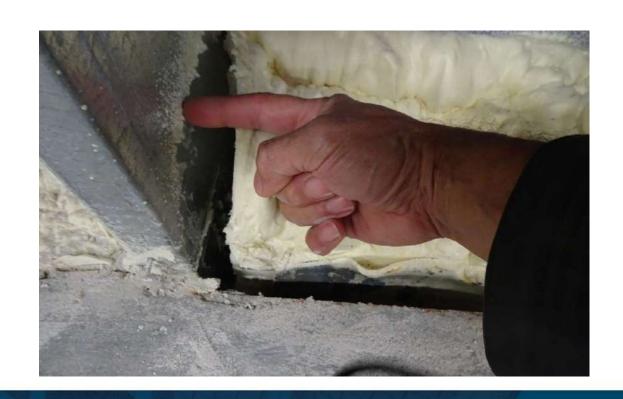
- Case Study 7: Spray Polyurethane Foam (SPF) Shrinkage
- Condition also discovered at second floor slab edge
- Shrinkage pulled SPF away from studs and slab edge face
  - Unacceptable air bypass condition

- Fix determined:
  - Determine areas needing repair
    - IR imaging
  - Create relief cut in existing plug
  - Install new cap layer over top
    - With renewed focus on processing and placement controls
  - Validate repair with IR imaging

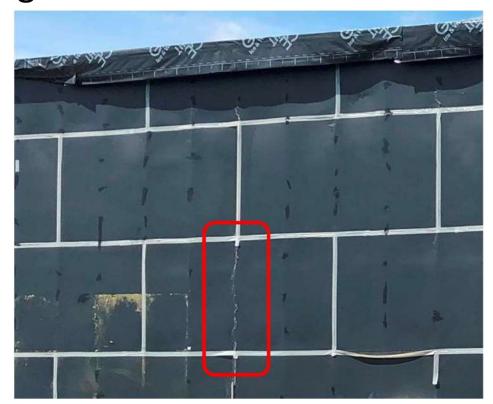
- Case Study 7: Spray Polyurethane Foam (SPF) Shrinkage
- Distress observed on outside face of sheathing
  - First noted ~3 months after install
  - Sheathing bowed inward
  - WRB cracked
  - Sheathing facer cracked

- WRB condition required repair
  - Cracks treated with additional flashing material

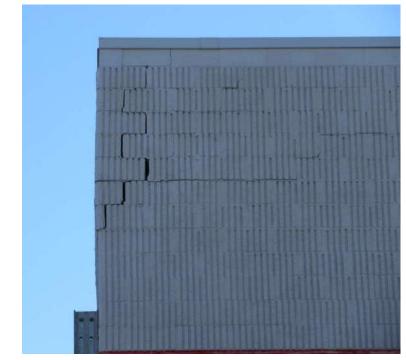
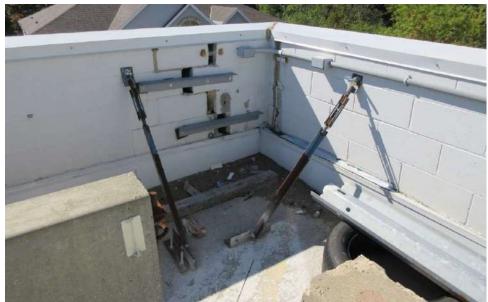
- Original construction complete ~ 2006
  - Leaking first observed ~ 2008
  - Substantial exterior wall cracking/movement at building corners
  - Accelerated wear slab deterioration
  - Numerous other issues, primarily structure-related

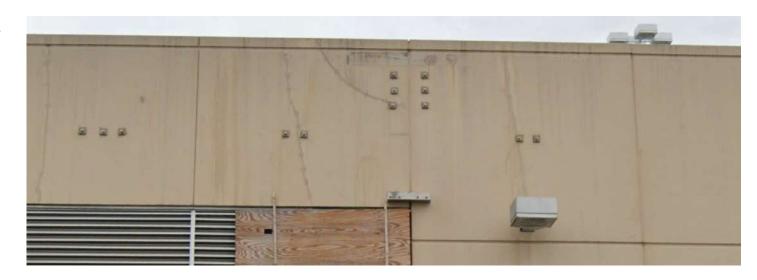
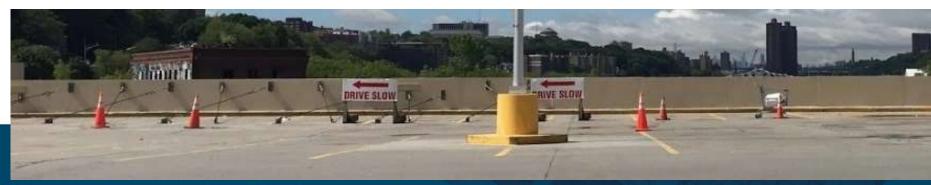
- Case Study 8: Slab Jacking/Plaza Deck Assembly
- Original construction complete ~ 2005
  - Leaking first observed ~ 2011
  - Substantial exterior wall outward movement
  - Accelerated wear slab deterioration
  - Tilting light pole bases

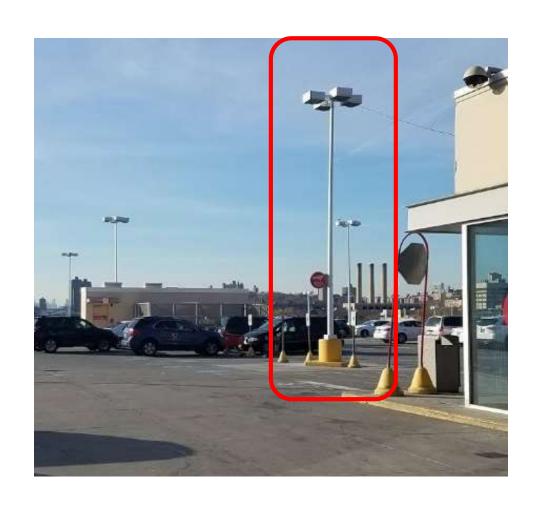
- Case Study 8: Slab Jacking/Plaza Deck Assembly
- Inadequate amount of expansion joints & sealed control joints
  - majority of wear slab expansion occurring at outer edges & corners
    - → slab movement distressing waterproofing layer to failure

- Case Study 8: Slab Jacking/Plaza Deck Assembly
- Progressive failure mechanism Wear slab
  - Shrink over winter months
  - Open up untreated control joints & new tensile cracks
  - Gaps fill with debris/roadway grit
  - Swell over summer months
  - Expand against debris-filled gaps
  - Each successive seasonal cycle would establish new baseline of overall horizontal dimension
- Eventually force of jacking on vertical waterproofing surfaces would cause breach

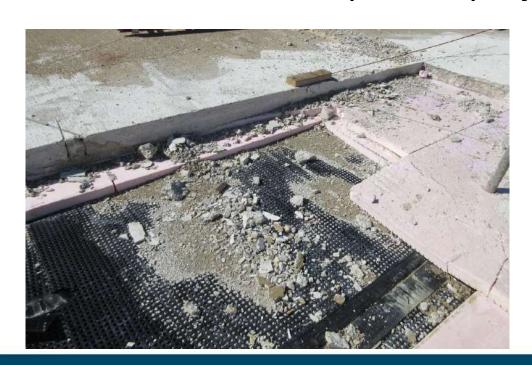
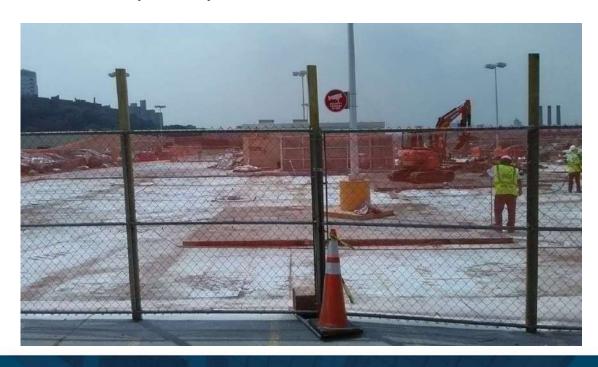
- Case Study 8: Slab Jacking/Plaza Deck Assembly
- Full removal & replacement on project 1 ~ \$7,000,000
- Limited removal & repair on project 2 ~ \$3,500,000

- Case Study 8: Slab Jacking/Plaza Deck Assembly
  - Remove assemblies down to structural slab
  - Replace WP layer (215 mil HRA)
  - Rebuild of rest of plaza assembly above
    - Additional drainage layer included above insulation
  - New wear course slabs
    - Much tighter pattern of control joints, ALL SEALED
    - Additional expansion joints
  - Followed by maintenance program recommendations
  - Regular surface sweeping
  - Wash down of decks in spring and fall
  - Regular inspection of construction and control joints
