abaa2024 building enclosure conference

Invisible Improvement: Air Tightening an Office in a Historic Pier

4EA Building Science

Air Tightening an Office in a Historic Timber Pier

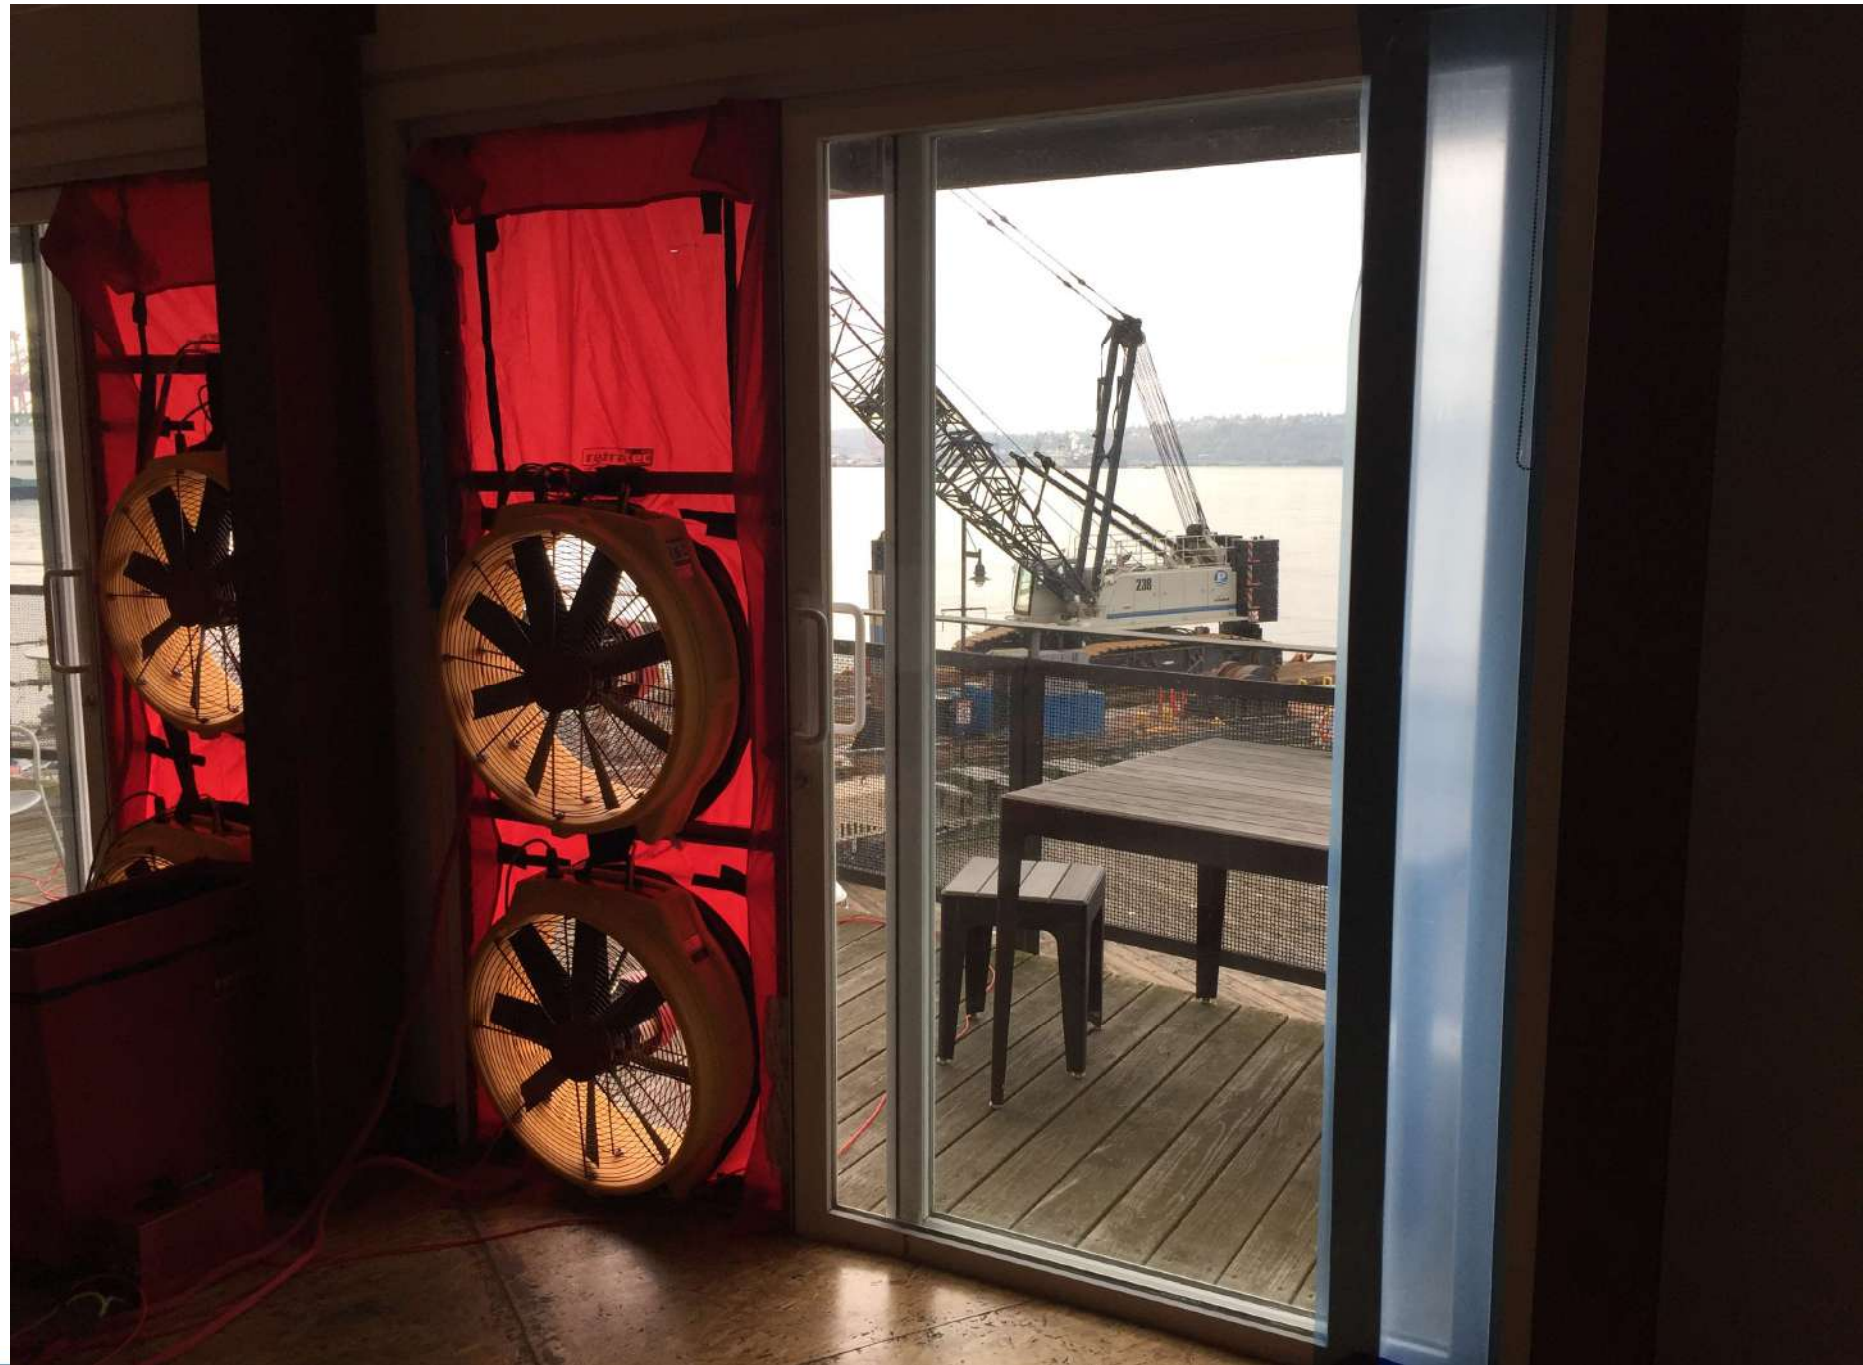
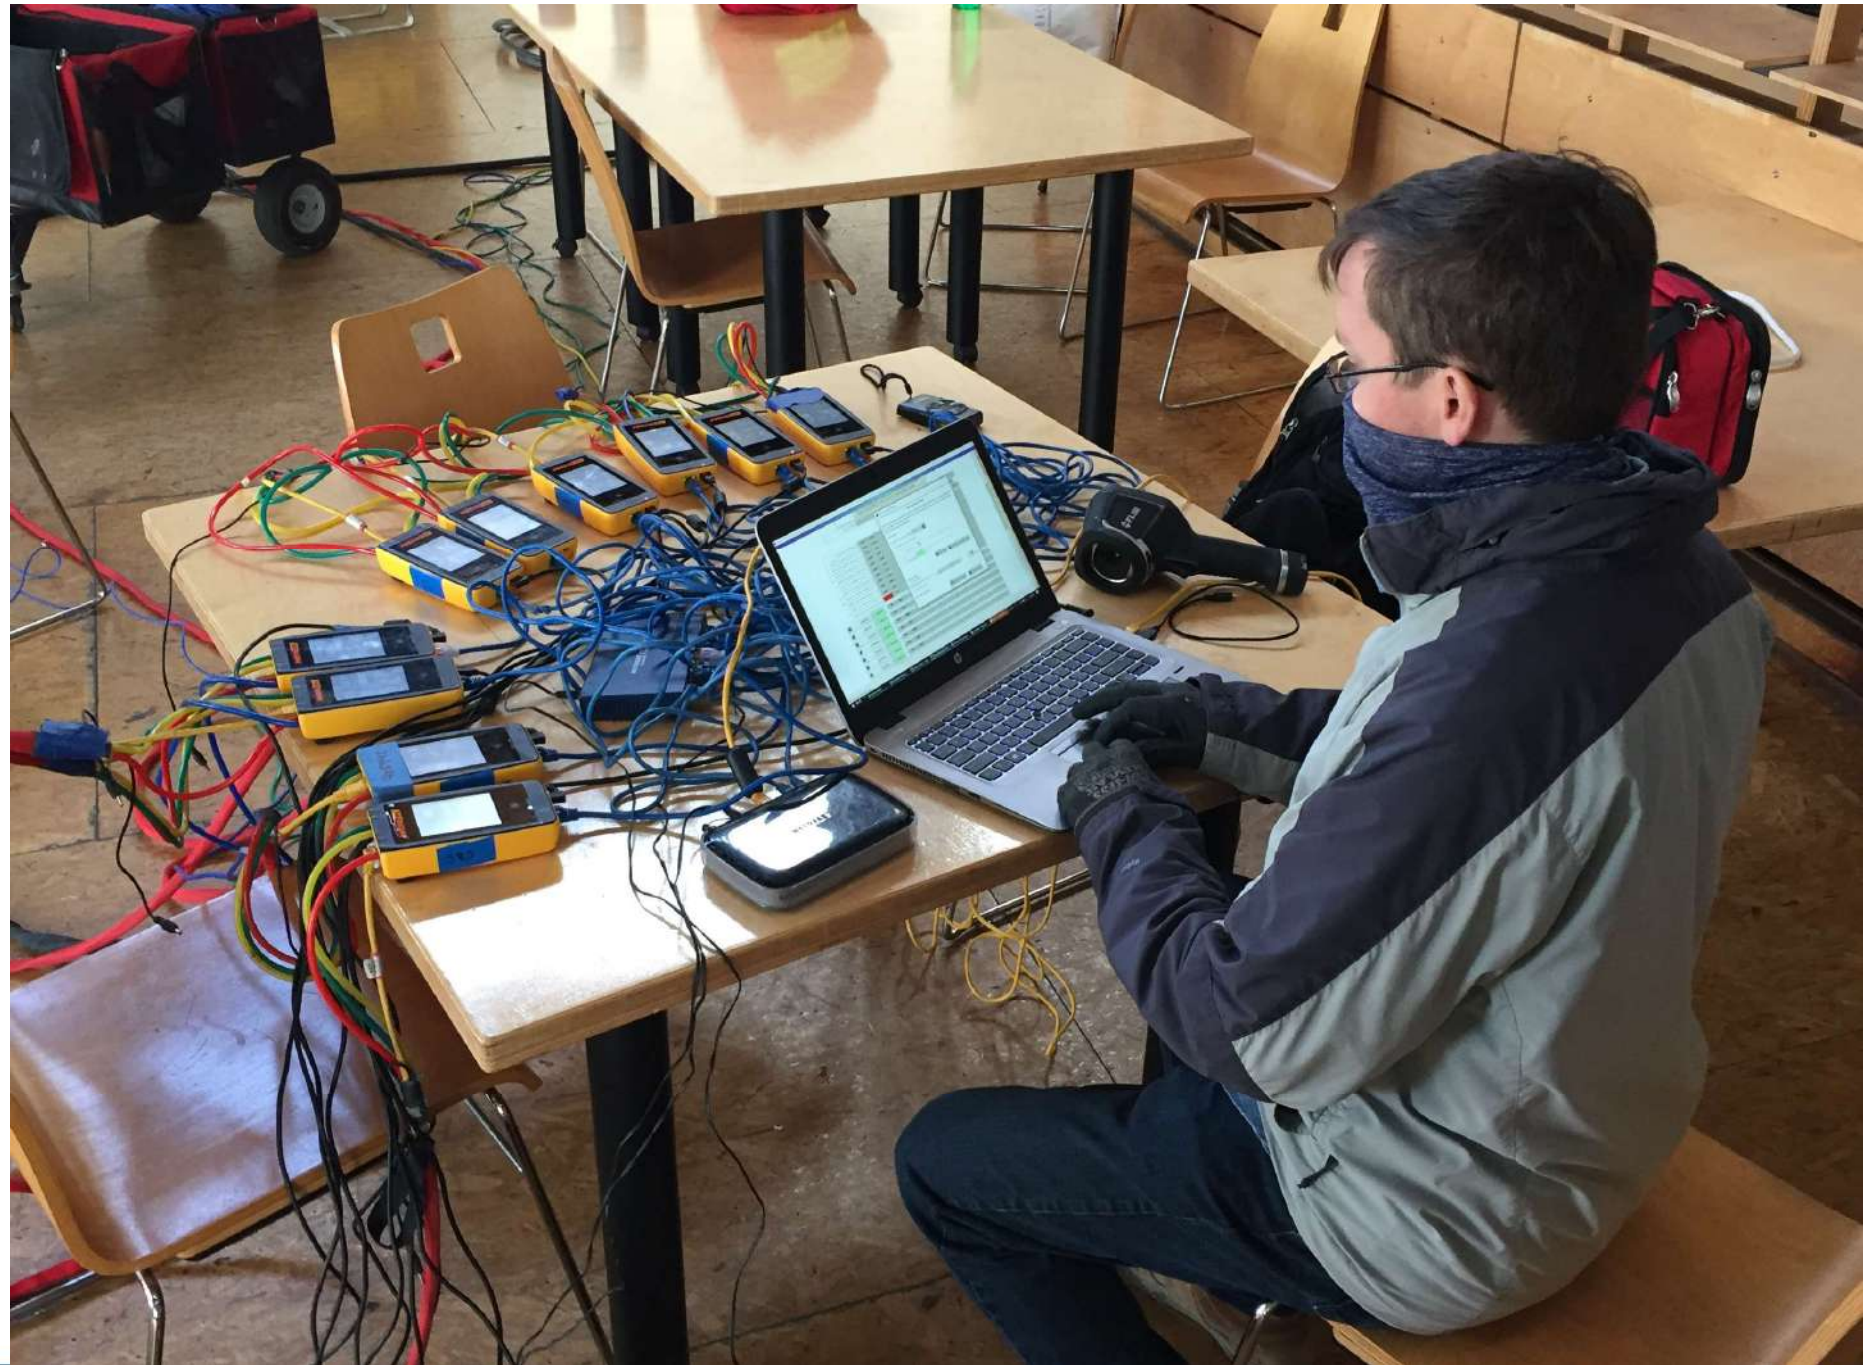
- 87, 524SF of enclosure area
- 10 high-capacity blower door fans
- Masking and temporary sealing completed
- Could not be isolated from the lower level
- Tested in October 2020

0.934 CFM/SF at 75 Pascals	Depressurization	5.915 ACH50
1.255 CFM/SF at 75 Pascals	Pressurization	8.134 ACH50
1.094 CFM/SF at 75 Pascals	Average	7.02 ACH50

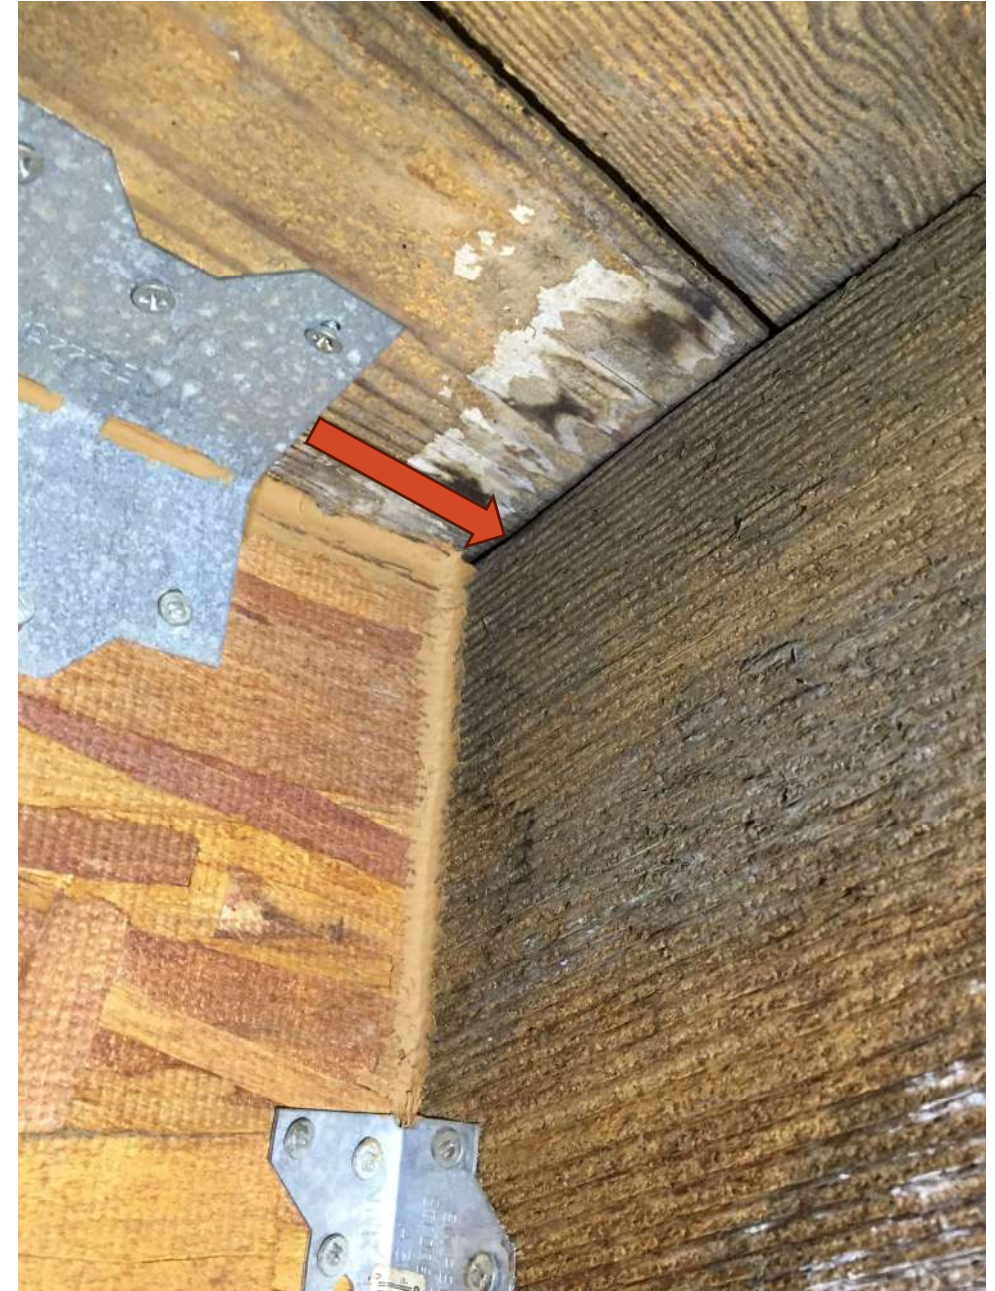
- Still room for improvement
- Some locations were missed or were not accessible
- Sealing of blocking at rafters was a 3D problem (car decking to rafters could not be sealed).
