# Catastrophic Failures and the Net Effect of Design and Construction Errors on Moisture Management, Resilience and the Built Environment

Building Forensics Group

# Gulf Residence Custom Home

# Limited Service Hotel

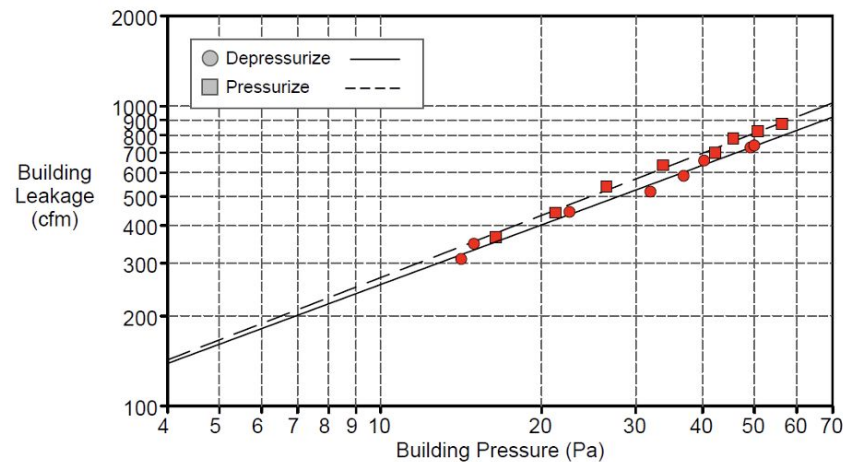
## House Tightness Test Details

Depressurization	Pressurization	Average
<b>Test Results at 50 Pascals:</b>			
Airflow (cfm50)	736 (+/- 3.6 %)	813 (+/- 2.5 %)	775 (+/- 2.2 %)
Air Changes per Hour 50 (1/h)	5.98	6.60	6.29
cfm50/ft² Floor Area	0.9934	1.0972	1.0453
<b>Leakage Areas:</b>			
Canadian EqLA @ 10 Pa (in²)	74.8 (+/- 10.4 %)	78.8 (+/- 9.4 %)	76.8 (+/- 7.0 %)
LBL ELA @ 4 Pa (in²)	39.4 (+/- 17.2 %)	40.5 (+/- 15.3 %)	40.0 (+/- 11.5 %)
<b>Building Leakage Curve:</b>			
Flow Coefficient (C)	55.6 (+/- 27.7 %)	54.9 (+/- 24.3 %)	55.3 (+/- 18.4 %)
Exponent (n)	0.660 (+/- 0.076)	0.689 (+/- 0.065)	0.675 (+/- 0.050)
Correlation Coefficient	0.99338	0.99557	
Test Standard:	E779		
Test Mode:	Depressurization and Pressurization

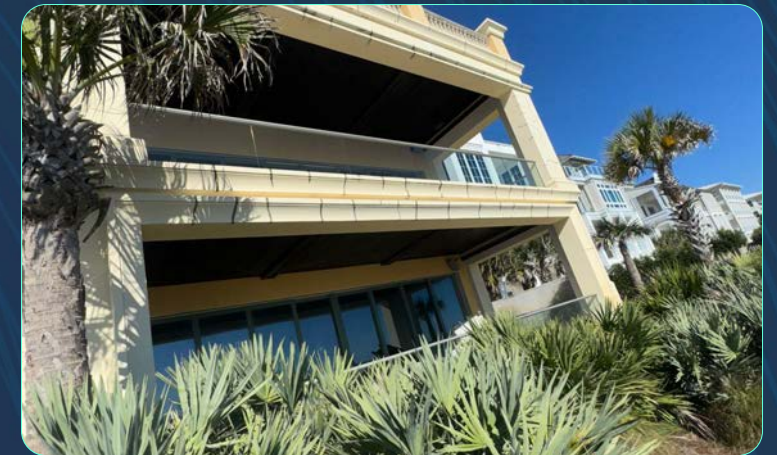
- No single defect caused the outcome. Each deficiency compounded the others. Errors are ranked by their contribution to the overall damage.

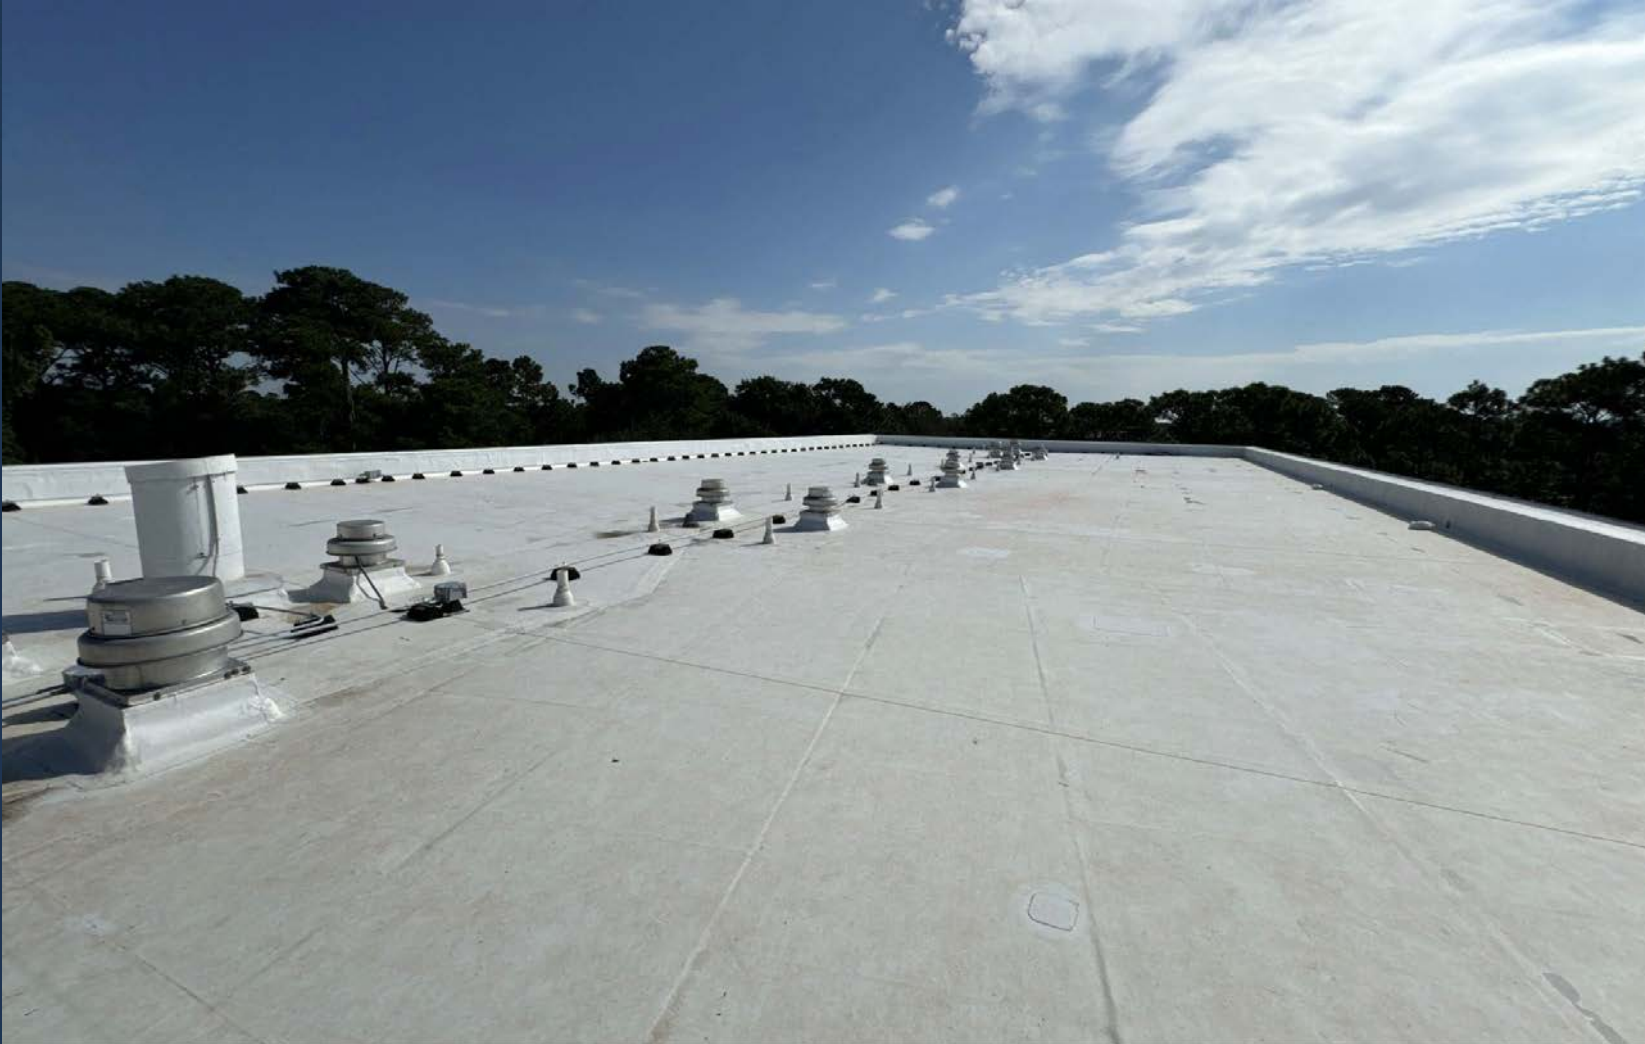
Roof View of Exhaust Fan Yard

- Mechanical openings, not the envelope, created infiltration paths.
