# Revisiting the Critical Link Between Engineering Mechanics and Enclosure Performance

"Systems thinking" is a term that is discussed at times in Building Science. But what if systems thinking asks us to consider more factors in the long term viability of enclosure integrity? While the relationship between structural movement and a structure's usefulness to its intended purpose has been well developed throughout the history of design and construction, that understanding has not always translated well into satisfactory enclosure performance.

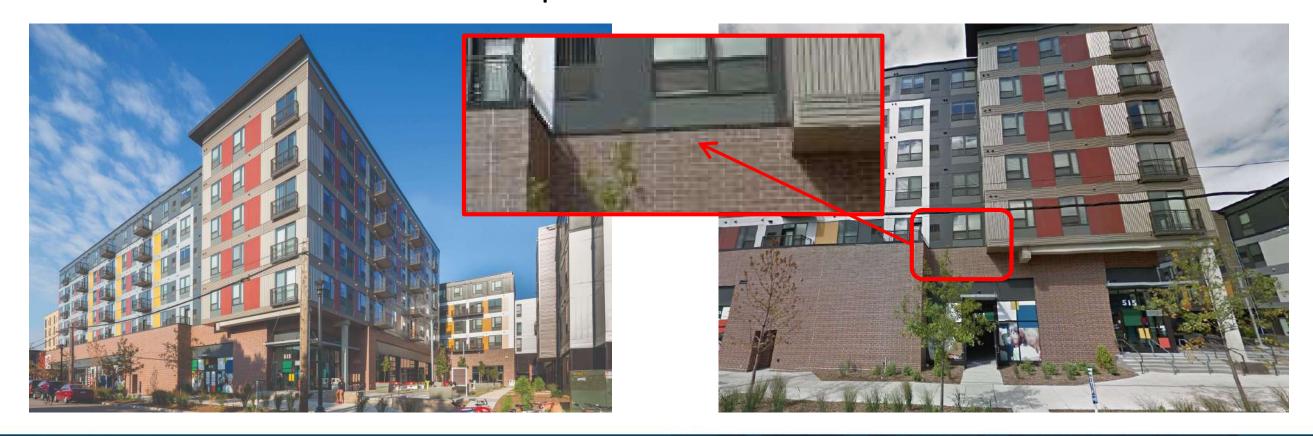
- Case Study 2: Wood Framed Stealth Deflections
- Sometime the movement potential is not as obvious

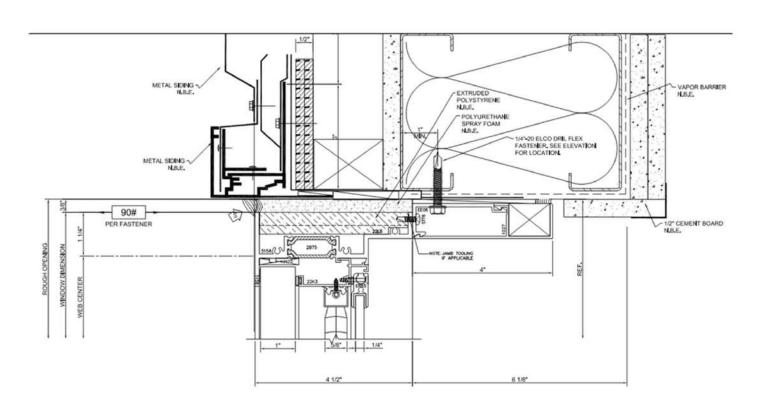
Window supplier's drawings showed static head joint consistent with contract documents

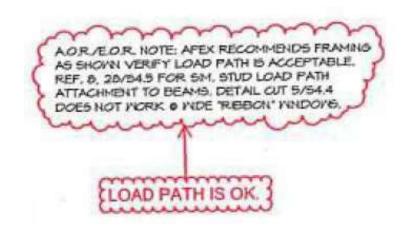
- Case Study 3: Stacked Ribbon Window/Steel Stud Infill
  - Architect approved request, but change was not communicated to any other parties affected by the decision
    - Particularly the window supplier with a static head joint

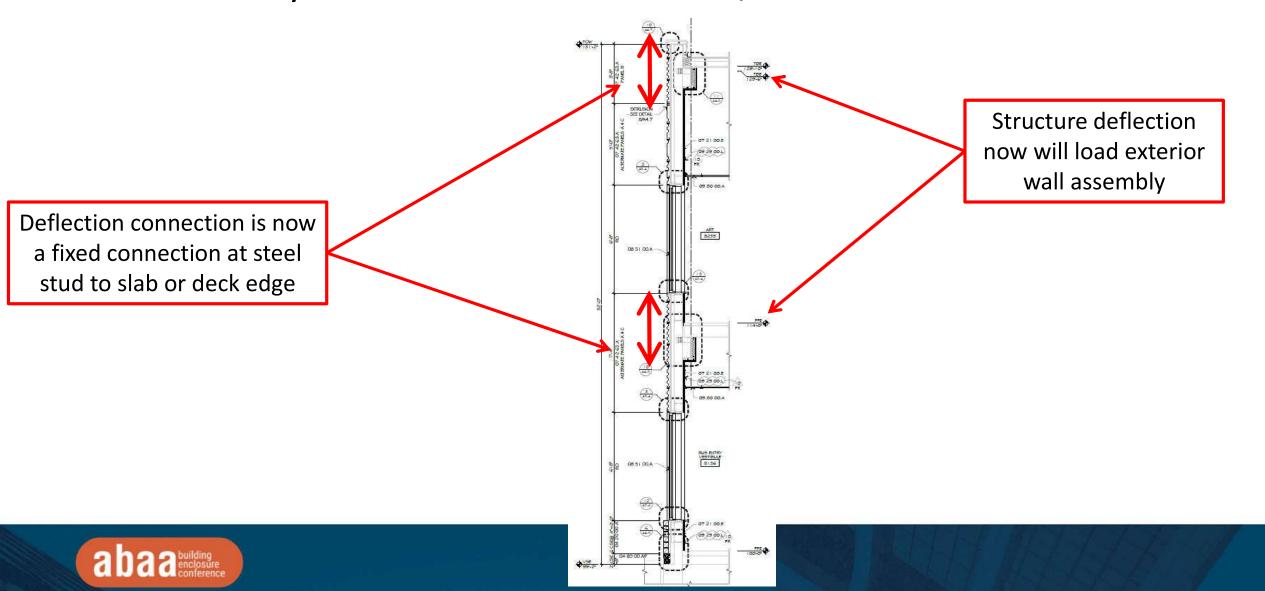
- Case Study 3: Stacked Ribbon Window/Steel Stud Infill
  - Window head conditions would leak early spring after seasonal cycle of winter snow load deflection followed by spring snow melt relaxation

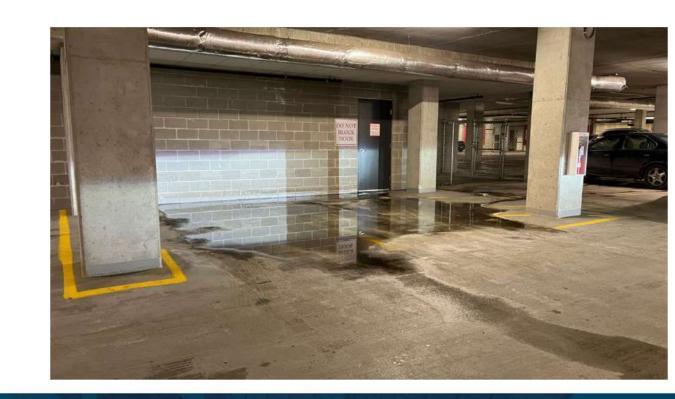
- Case Study 4: Parking Deck Surface Slopes/Water Infiltration
- Primary goal for ACI is to prevent standing water, which will reduce
  - Water intrusion INTO slab thickness
  - Accelerated deterioration of reinforcing and concrete

- Case Study 4: Parking Deck Surface Slopes/Water Infiltration
- Movement of slab changed surface slope from adequate to inadequate
  - Enclosure no longer protected cars below
- Persistent standing water on upper ramp level throughout winter months

- Moisture runoff changed from neutral to alkaline
- Vehicle owners changed from happy to upset
  - Parking structure owner paid for auto finish repair work
  - Vehicular traffic coating added ~ \$355,000

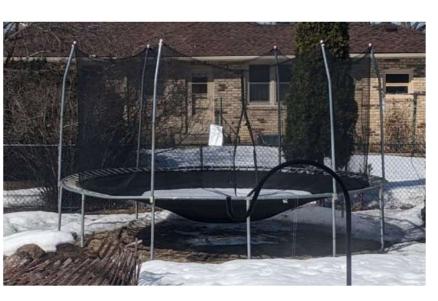
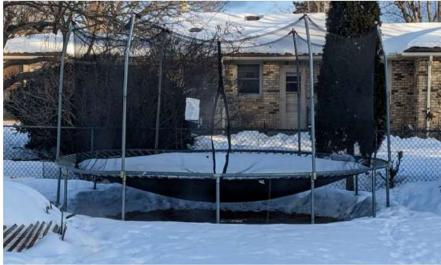
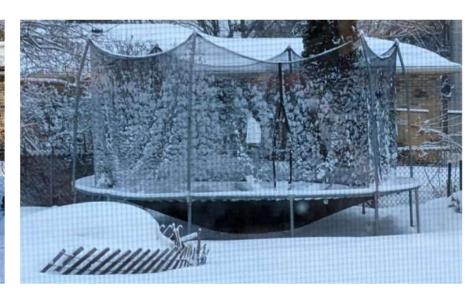
Progressive deflection from ponding instability

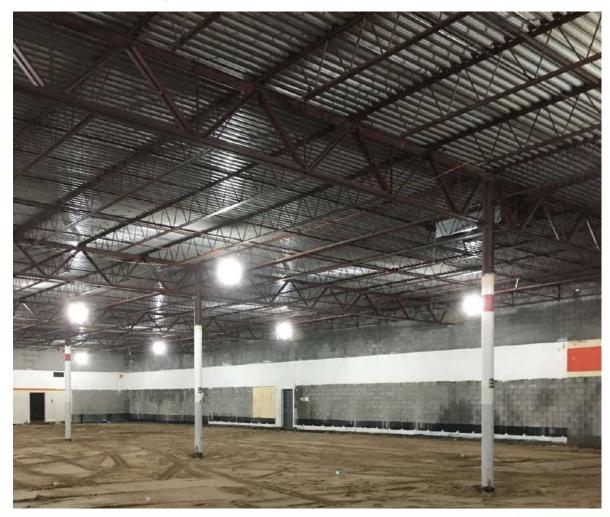
- Case Study 5: Roof Ponding/Adaptive Reuse Project
- Existing roof structure design was only marginally above original code minimums
  - Open web steel joists
  - Roof framing sloped 1/8" per foot
  - Existing roof assembly saturated

- Case Study 5: Roof Ponding/Adaptive Reuse Project
- Local Code allowed for roof slopes shallower than ¼" per foot
- Modifications did not trigger extensive retrofit requirements
  - Ponding analysis was not performed by design team

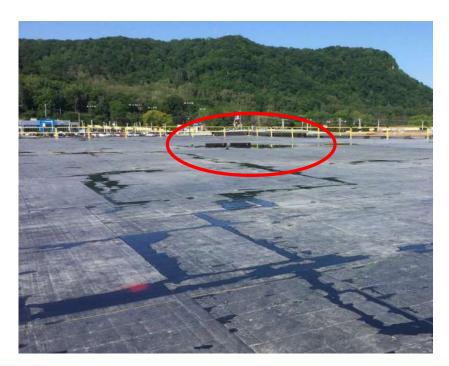
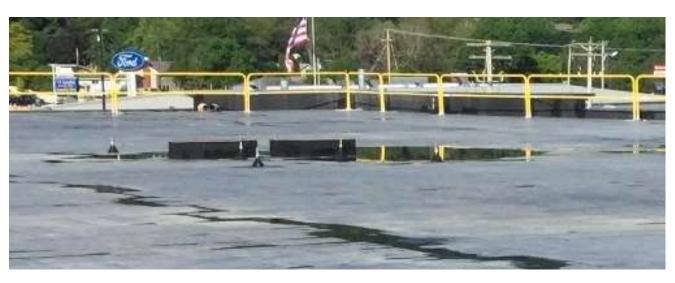
- Case Study 5: Roof Ponding/Adaptive Reuse Project
- There were early warning signs
  - Construction team could have alerted structural engineer to birdbaths

- Case Study 5: Roof Ponding/Adaptive Reuse Project
- This particular instance did not result in a critical life-safety issue
- Nevertheless
  - Cumulative roof ponding as a result of not considering building movement is a serious issue that has resulted many roof collapses
  - Slopes shallower than ¼" per foot always warrant careful consideration, regardless of code requirements.

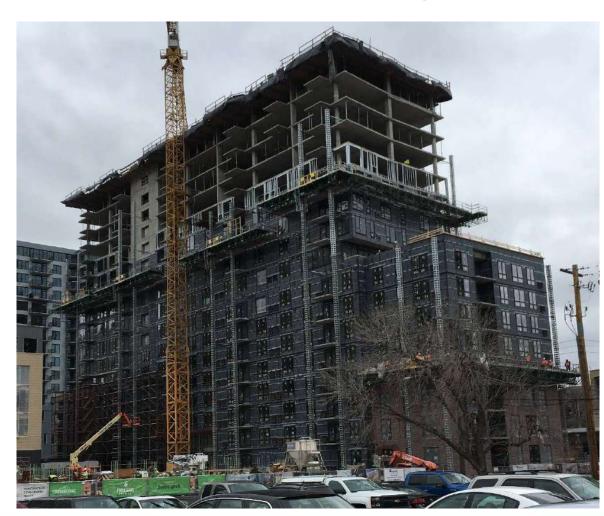
- Case Study 6: Solar Heat Gain/Self-Adhered Membrane Flashing
- Enclosure work occurred throughout winter (Climate Zone 6a)
  - End of December during installation, gapping or "fish mouthing" was discovered at outer edges of flashing
  - Raised folds also discovered in field of material

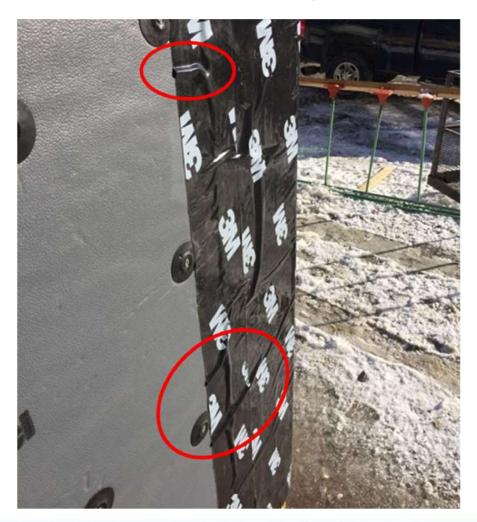
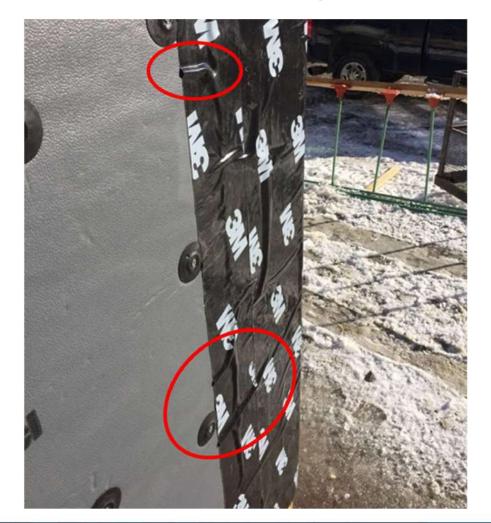
- Flashing would
  - be flat/smooth before direct morning sunlight
  - gap open when exposed to sun
  - Then return to flat after sun set in afternoon

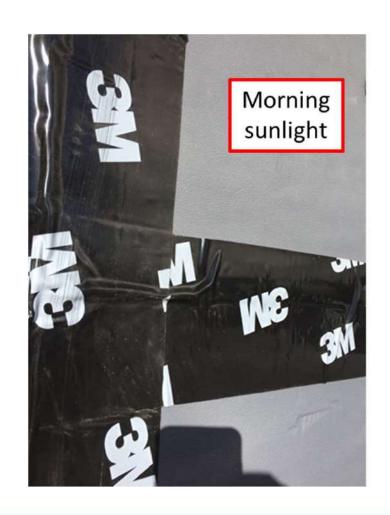
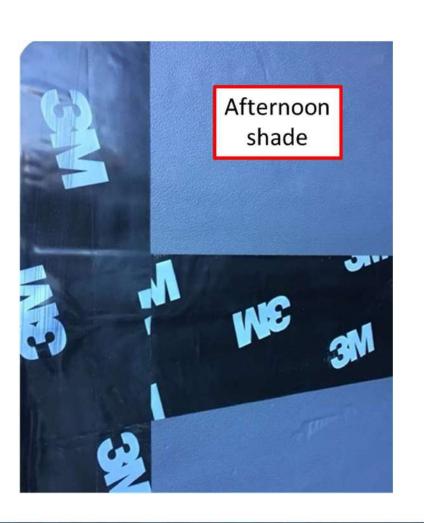
- Case Study 6: Solar Heat Gain/Self-Adhered Membrane Flashing
- Surface temperature readings taken
- Days with direct sunlight the surface temperatures would exceed 130 degrees
  - Ambient air temperatures around 30 degrees

- → solar heat gain
  - → material expanded at a rate greater than substrate
    - expansion overcame adhesive force
- Any fish mouths terminating on an upward edge determined to be a moisture infiltration risk

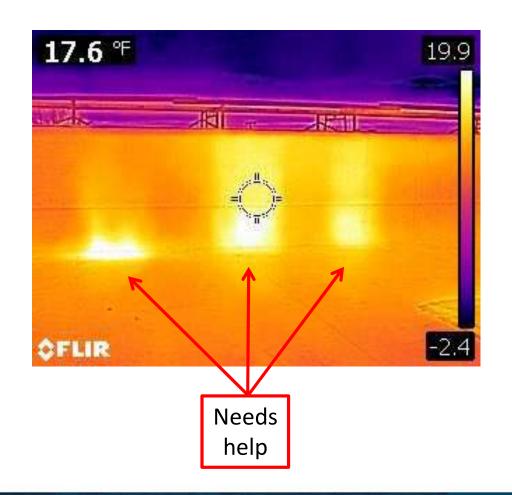
- Case Study 7: Spray Polyurethane Foam (SPF) Shrinkage
- Condition also discovered at second floor slab edge
- Shrinkage pulled SPF away from studs and slab edge face
  - Unacceptable air bypass condition

- Fix determined:
  - Determine areas needing repair
    - IR imaging
  - Create relief cut in existing plug
  - Install new cap layer over top
    - With renewed focus on processing and placement controls
  - Validate repair with IR imaging

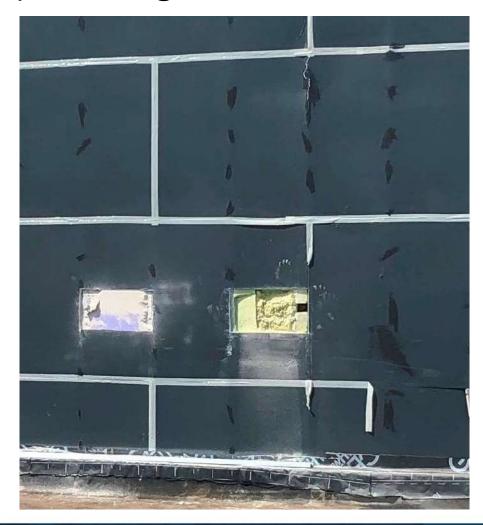
- Inspection Openings Made
  - SPF shrinkage confirmed
- Site visit from both SPF Manufacturer
   & WRB Manufacturer

SPF condition determined acceptable

- WRB condition required repair
  - Cracks treated with additional flashing material

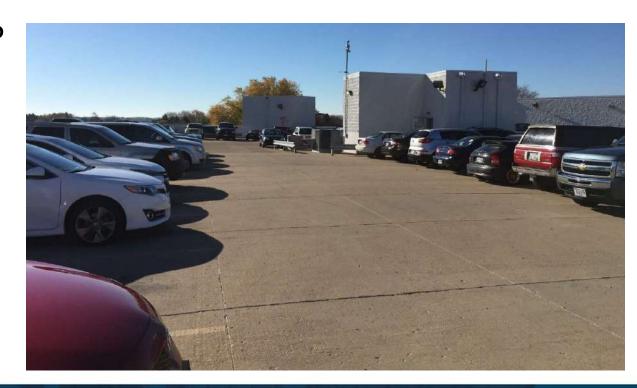
- Project 1
  - Typical Assembly Construction, but WP layer was 60 mil EPDM (not ideal)
  - Parking deck above auto dealership for auto storage

- Original construction complete ~ 2006
  - Leaking first observed ~ 2008
  - Substantial exterior wall cracking/movement at building corners
  - Accelerated wear slab deterioration
  - Numerous other issues, primarily structure-related

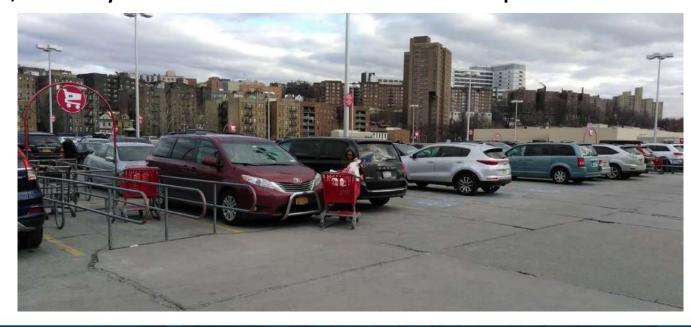
- Case Study 8: Slab Jacking/Plaza Deck Assembly
- Original construction complete ~ 2005
  - Leaking first observed ~ 2011
  - Substantial exterior wall outward movement
  - Accelerated wear slab deterioration
  - Tilting light pole bases

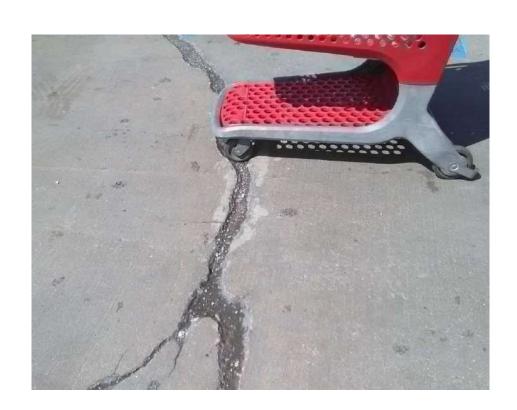
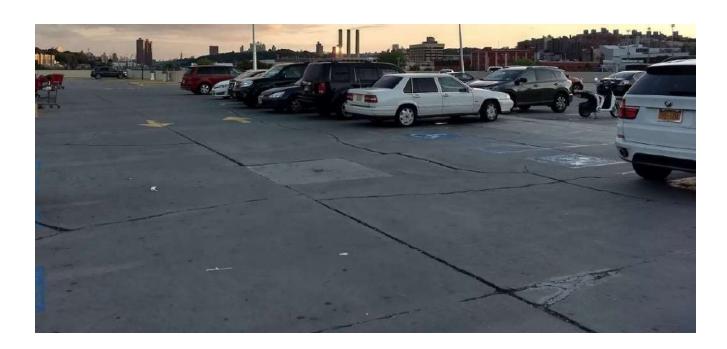
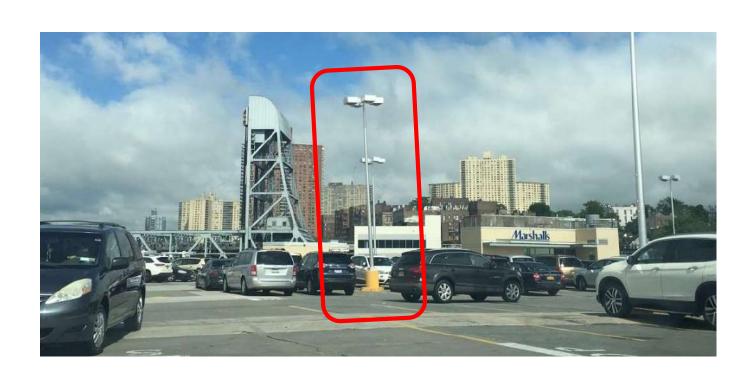
- Case Study 8: Slab Jacking/Plaza Deck Assembly
- Inadequate amount of expansion joints & sealed control joints
  - majority of wear slab expansion occurring at outer edges & corners
    - → slab movement distressing waterproofing layer to failure

- Case Study 8: Slab Jacking/Plaza Deck Assembly
- Progressive failure mechanism Wear slab
  - Shrink over winter months
  - Open up untreated control joints & new tensile cracks
  - Gaps fill with debris/roadway grit
  - Swell over summer months
  - Expand against debris-filled gaps
  - Each successive seasonal cycle would establish new baseline of overall horizontal dimension
- Eventually force of jacking on vertical waterproofing surfaces would cause breach

- Case Study 8: Slab Jacking/Plaza Deck Assembly
  - Remove assemblies down to structural slab
  - Replace WP layer (215 mil HRA)
  - Rebuild of rest of plaza assembly above
    - Additional drainage layer included above insulation
  - New wear course slabs
    - Much tighter pattern of control joints, ALL SEALED
    - Additional expansion joints
  - Followed by maintenance program recommendations
  - Regular surface sweeping
  - Wash down of decks in spring and fall
  - Regular inspection of construction and control joints

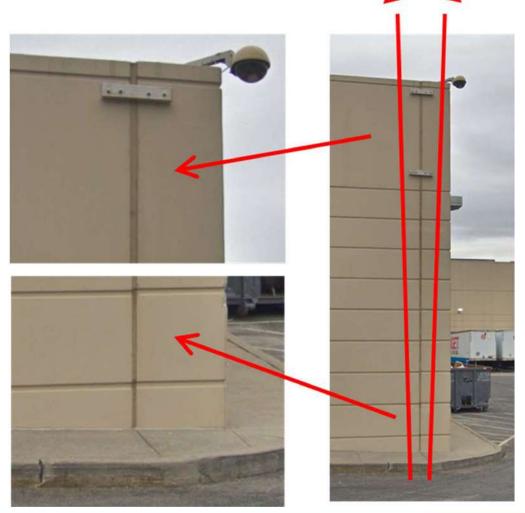
Case Study 8: Slab Jacking/Plaza Deck Assembly

Volume change → compression and shear force

• Findings were controversial on project 2 — "It has to be the snow plow impact force!"

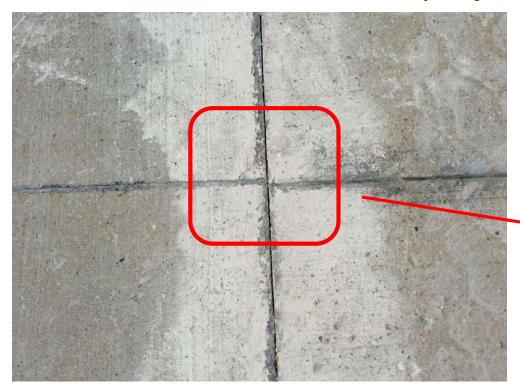
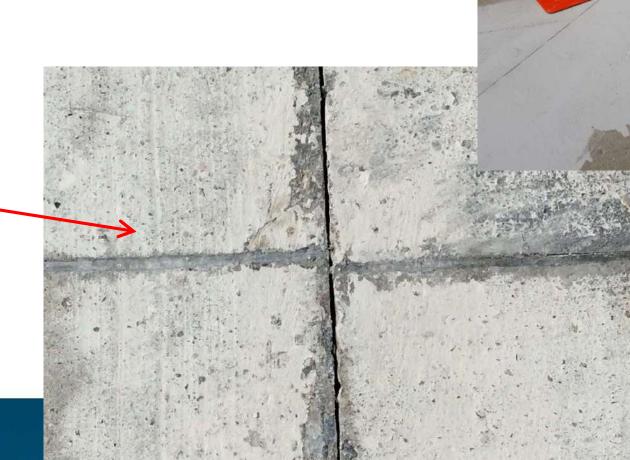
Horizontal forces in project 1 were significant

- Case Study 8: Slab Jacking/Plaza Deck Assembly
- Full removal & replacement on project 1 ~ \$7,000,000
- Limited removal & repair on project 2 ~ \$3,500,000
