abaa2024 building enclosure conference

Invisible Improvement: Air Tightening an Office in a Historic Pier

4EA Building Science

Air Tightening an Office in a Historic Timber Pier

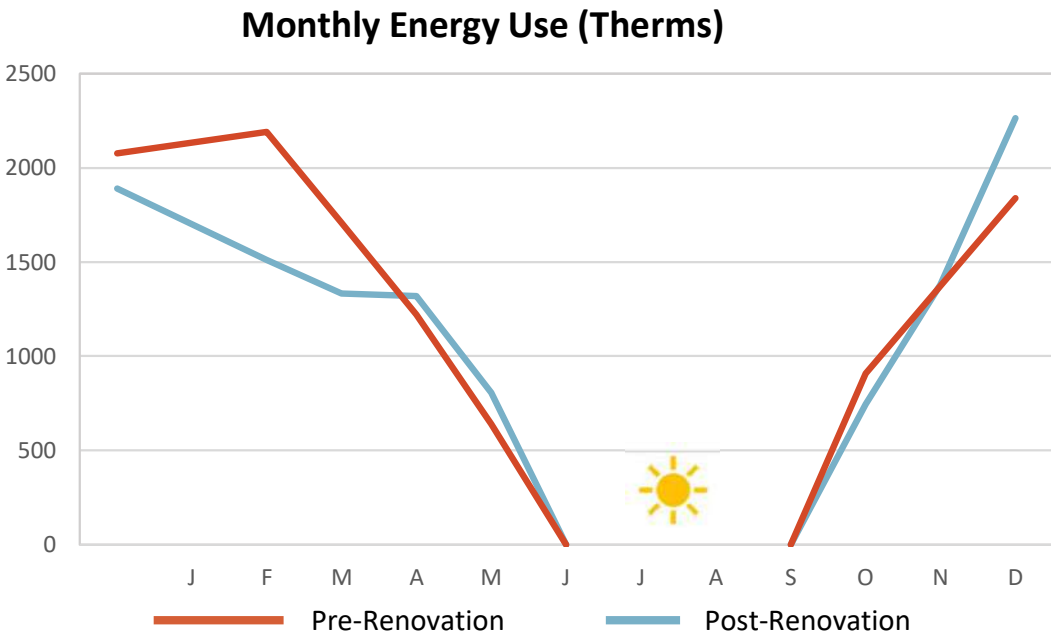
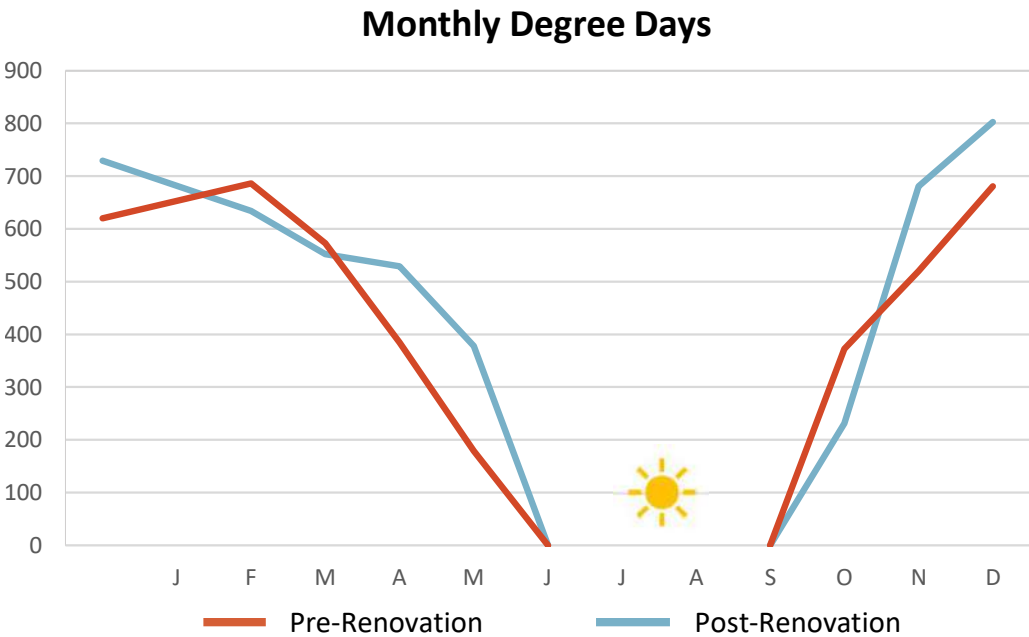
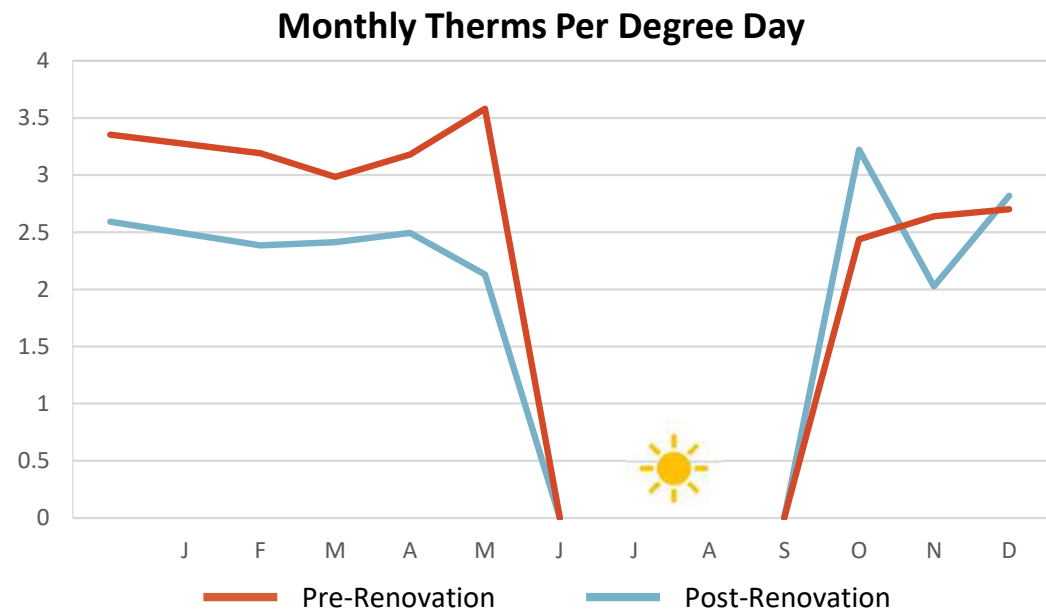
After the first year of occupancy space heating was a 36.24 EUl, a 15.9% reduction in space heating energy use.

Normalized for weather, the savings were 16.8%.
